Indian Journal of Clinical Anaesthesia

## Case Report

## Covid-19 and a lost guidewire: A misty tale of misery!

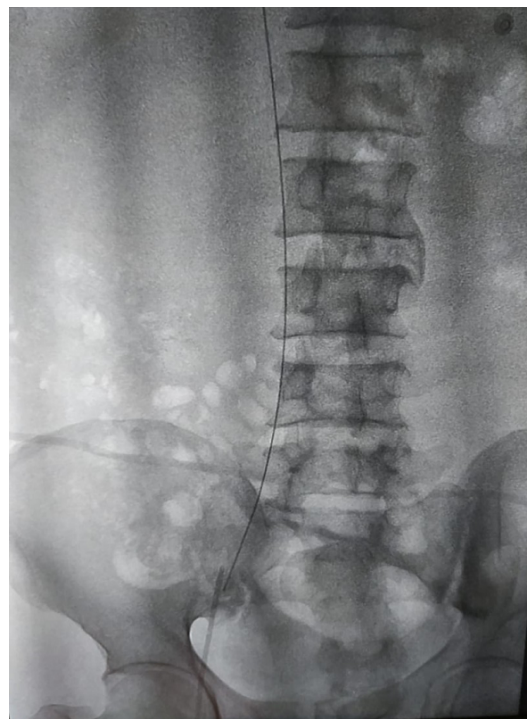
A 60-year-old male presented to emergency department in gasping state. His rapid antigen test for COVID-19 was positive and presented with history of high-grade fever as well as shortness of breath for one day. His oxygen saturation at time of presentation was 52% on room air. He was immediately shifted to COVID ICU where he underwent endotracheal intubation in view of worsening respiratory distress and falling oxygen saturation. His chest X-ray showed bilateral peripheral radiodensities and consolidation suggestive of COVID-19. In COVID ICU, due to hemodynamic instability and unavailability of peripheral venous access, femoral venous catheterisation was planned. In the absence of ultrasound in ICU, other sites were not attempted as patient was already hypotensive and in a compromised state. Right femoral vein was catheterised using Seldinger technique by an anaesthesiologist with five years of experience. The anaesthesiologist was already working in COVID ICU in PPE for last 5 hours. The procedure was uneventful with no difficulty in cannulation and back flow from all three ports were present. At the end of the procedure, it was found that the guide wire was missing in the tray. During the procedure, the guide wire was not gripped properly due to poor tactile control (wearing two gloves) and visual insufficiency (fogging of goggles).

**Fig. 1:** Lower end of guidewire

Intervention radiology is the recommended method for retrieval of lost guidewire.<sup>5</sup> After initial stabilisation of ventilation and haemodynamic parameters, the patient was shifted to interventional radiology suite following appropriate protocols. In presence of interventional radiologist, the patient underwent exploration of right femoral vein under fluoroscopy. Proximal end of the guidewire was seen at the level of common iliac vein (Figure 1) and the distal end (J end) was seen in neck, at the level of right IJV (Figure 2). Right femoral vein was accessed by a 7 French sheath and an angled wire loop retriever (CloverSnare<sup>®</sup> vascular retriever by Cook medical). Venography was performed via sheath which revealed normal common iliac vein & inferior vena cava and guide wire in situ. Then, 0.035-inch snare was introduced through the guiding catheter and the guide wire was hooked by snare (Figure 3). Finally, the whole assembly was extracted via sheath. Post guide wire removal, repeat venography revealed normal common iliac vein and inferior vena cava. The sheath was then removed from femoral vein and entire procedure was uneventful. The patient was later shifted back to COVID ICU for further management after performing a chest x-ray (Figure 4).

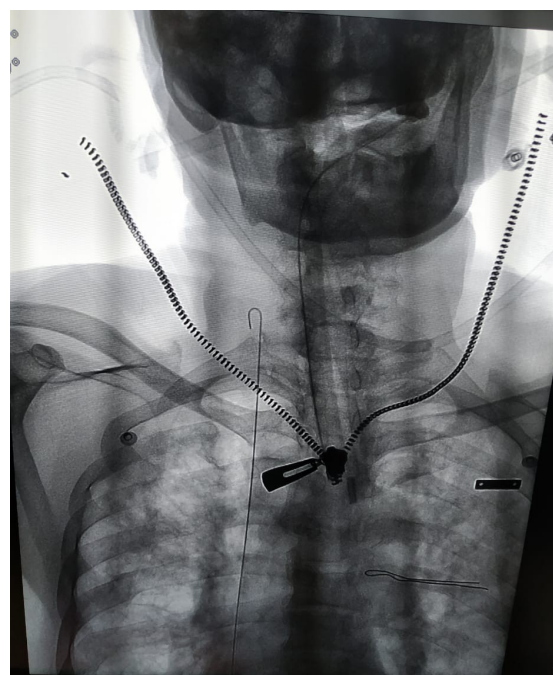
**Fig. 2:** Upper end of the guidewire

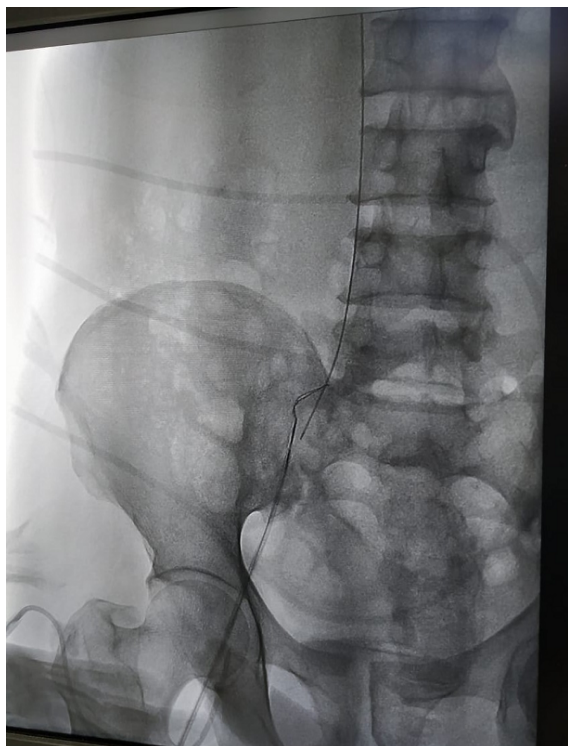
**Fig. 3:** Retrieval of guidewire

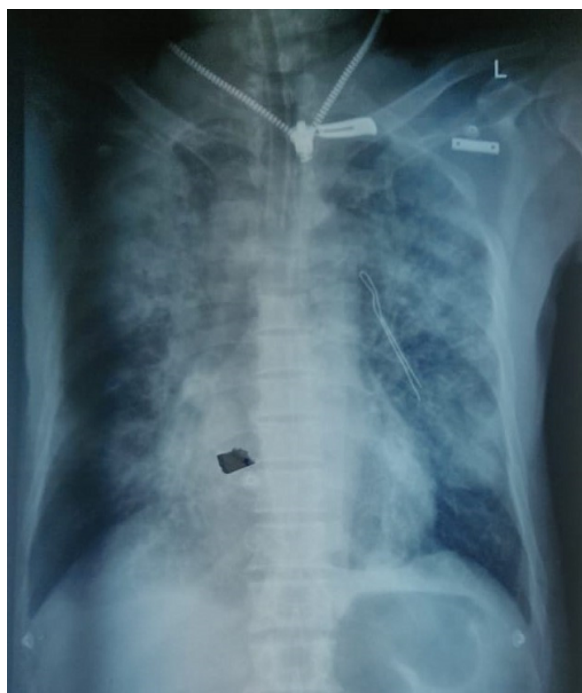
**Fig. 4:** Post procedure X ray
