VIBRATION ANALYSIS AND REPAIR PROCESS FOR THE VENTILATION SYSTEM FOR SMOKE DRAIN IN THE THERMAL POWER PLANT

Original scientific paper

Process of vibration analysis followed by present cause of increased vibration in rotating machinery repairing is presented in this paper through the example on the ventilation system for smoke drain in the coal-heated thermal power plant Kakanj, Bosnia & Herzegovina.

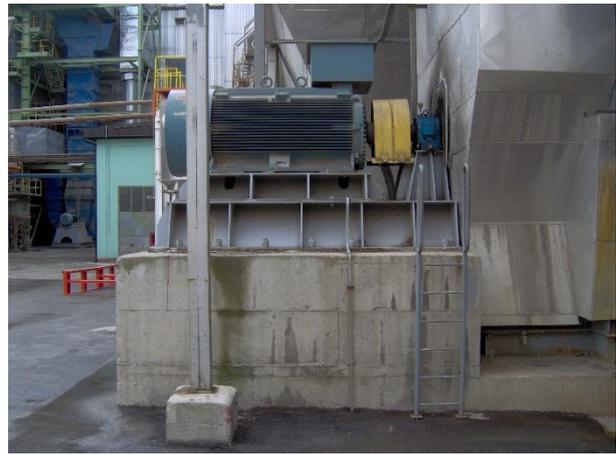
Fig.1. Motor flexibly coupled with ventilator

Ventilation system is shown in Fig.1.

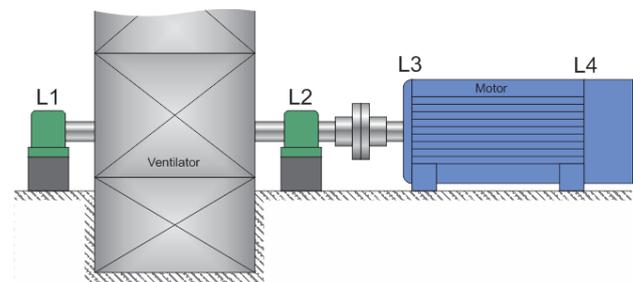
Fig.2. Names of measurement locations

Vibrations are measured on the housings of the motor and the ventilator bearings in three perpendicular directions: horizontal, vertical and axial. Measurements are marked with L1 and L2 for ventilator bearings, and L3 and L4 for motor bearings. Accelerometers of type KD 37V and KD 41V are used for measurements. Accelerometers are connected to Spider 8 device for data acquisition through M28 power supply. Spider 8 is then connected to the computer, which is used for data recording. Magnetic stands with screws are used for accelerometer mounting on housings, so it is easy to detach them after measuring.

Locations of bearings where measurements are done are shown on Fig.2.

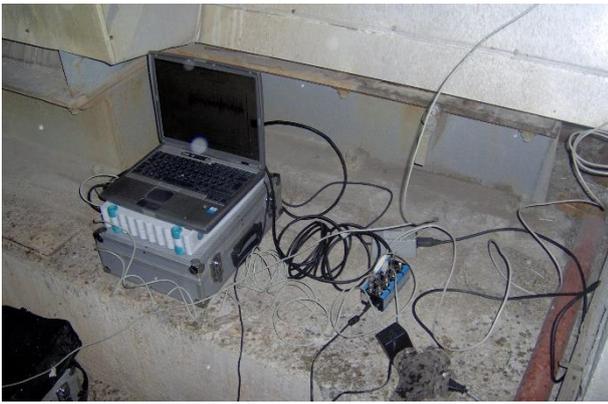
Fig.3. Computer, Spider 8 and M28 power supply

Equipment used for data acquisition and measurement recordings is shown on Fig.3, and measurement scheme is shown on Fig.4.

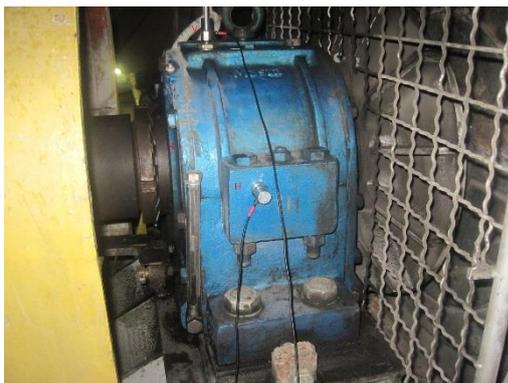
Fig.5. Bearing housing with accelerometer attached

On Fig.5 is shown one of the bearing housings with accelerometers attached to the measuring spots.

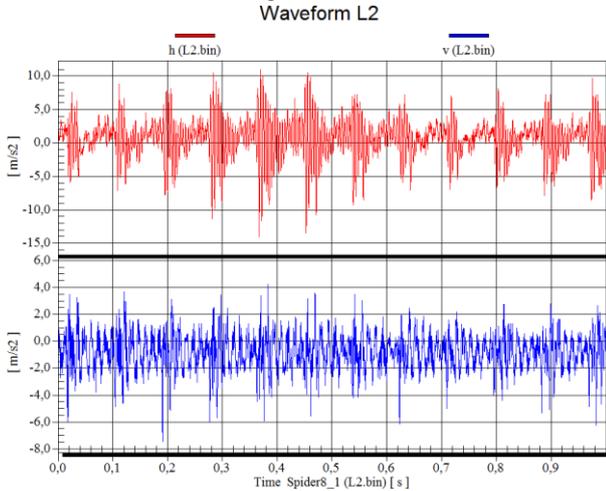
Fig.6. Waveform of acceleration for L2 (H and V)

Recorded acceleration data is analysed by its waveform characteristics. On Fig.6 and 7 are shown waveforms for bearings L1 and L2 on the ventilator.

On the waveform for horizontal and vertical direction on bearing L1 some impacts could be noticed, which also transfers to horizontal direction on bearing L2. The shape of letter M and W could be also noticed on the waveform for horizontal direction of bearing L2. Those characteristics could suggest that combination of misalignment and looseness could be main faults of this system.

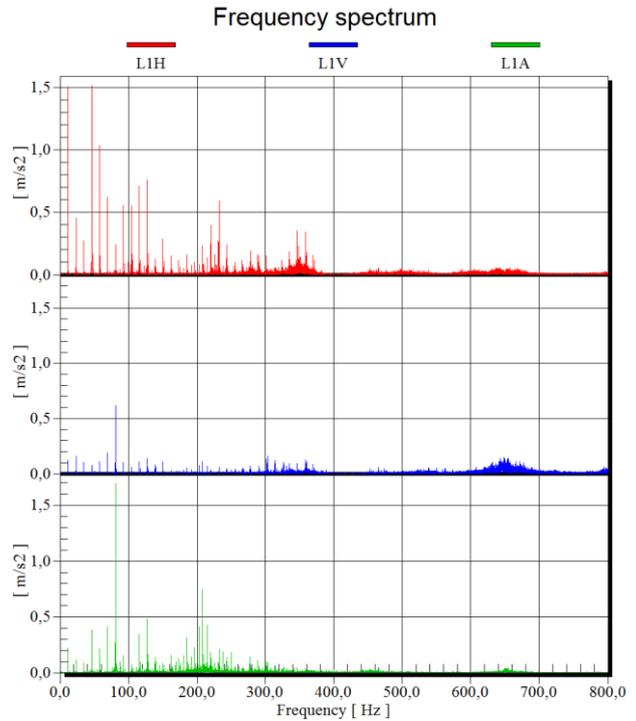
Fig. 8. Frequency spectrum of L1 acceleration (0-800 Hz)

From the recorded accelerograms, frequency spectrums are created. On Fig.8 and Fig.9 are shown accelerograms for measurements done on ventilator bearings L1 and L2 in range from 0 Hz to 800 Hz when ventilator had 705 rpm.

On frequency spectrums rotating frequency and its multiple orders are noticeable. It could be also noticed some nonsynchronous frequencies (226 Hz, 346 Hz) where some of them could be bearing frequencies. Some floor noise is raised for frequency spectrum measured on the L1 bearing. Frequency spectrum characteristics shown on Fig.8 and 9 are suggesting that possible cause of high

vibrations is misalignment and looseness, which already caused bearing failure.

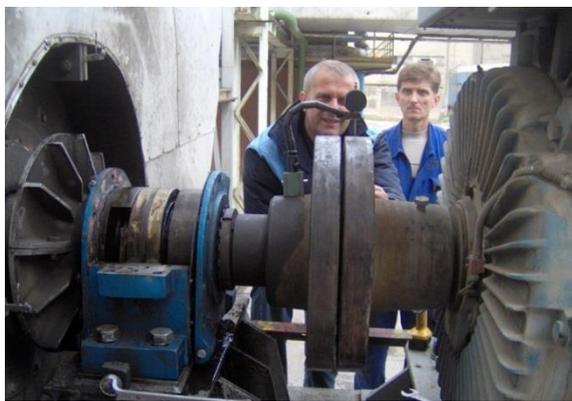
Fig.10. Misalignment measurement on coupling

First step was to decrease misalignment level, Fig.10. During misalignment measurement, it is noticed that the ventilator shaft journal is radially moving inside bearing closer to the coupling. By measuring radial movement of shaft on both sides of bearing it is concluded that ventilator shaft journal is bent.

On the coupling of ventilator shaft side is measured that shaft journal is 1 mm bent on that end of shaft. It is concluded that best solution is to distribute that 1 mm of bent shaft journal on 0,5 mm on each sides of motor shaft. Aligning procedure is done with radial and angular measurement (edge – face), where angular misalignment is reduced to <0,05 mm per 100 mm length, and radial misalignment is distributed horizontally and vertically by 0,5 mm.

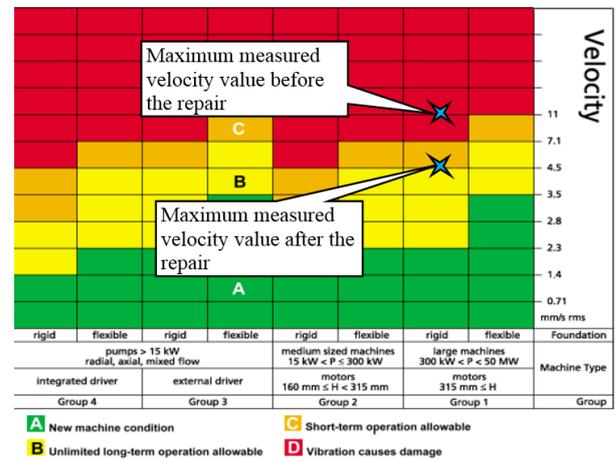
Fig.11. Vibration grade according to ISO 10816 before and after the quick repair process

On Fig.11 are shown levels of measured vibrations before and after the repair process. This ventilation system belongs to group 1 of machines with nominal power greater than 300 kW and with rigid foundations.

As it could be seen, before quick repair process, maximum vibration level was larger than 7,1 mm/s which is lowest value of class D, where vibration could cause damage. After the quick repair process, highest value of vibrations was just above the 4,5 mm/s, which is satisfying class C, which allows short-term operation. According to ISO 10816, ventilation system is operable until it is possible to start its main reparation process.

As it could be seen, highest value of vibrations on bearing L1 is decreased from 6.1 mm/s (705 rpm) to 4.6 mm/s (686 rpm), and for bearing L2 is decreased from 11.2 mm/s (705 rpm) to 3.6 mm/s (456 rpm). This drastic reduce of the vibration levels are due to distribution of ventilator bent shaft on both sides of motor shaft.

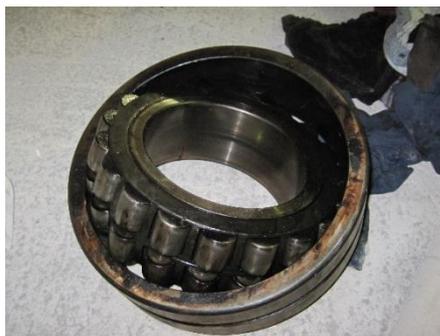
Fig.12. Visible traces of skidding on inner ring

Main repair process started after the few weeks. Ventilator was disassembled and shaft and bearings were examined. It is determined that shaft journal was bent on its end closer to coupling. Since it was bent, it damaged the bearing closer to the coupling and shaft journal was slipping inside. This could be seen on Fig.12, where traces of slipping are visible on bearing inner ring.

Similar traces are visible also on journal where this bearing was mounted. Most possible scenario in this case was that shaft mounted on ventilation system was already bent. Because of that, bearing was loaded over its maximum force and journal grinded inside inner ring of bearing and made some gap, so journal could skid inside the bearing. Since shaft was bent, it acted similar as misalignment. And since it made some gap between journal and bearing inner circle, it also had some frequency spectrum characteristics similar to misalignment frequency spectrum. Velocity RMS values after the main reparation process is shown in Table 6.

After the main reparation process where shaft and bearings are changed with new parts, vibrations are measured. It is shown that all vibration levels

are classified as A, which is stated as a new machine condition.
