Physical, Mechanical and Chemical Characterization on Ancient Brick Masonry of Monuments, Bagan, Myanmar

Thet Mon San, Kyaw Kyaw, Nyan Myint Kyaw

Department of Civil Engineering, Yangon Technological University, Yangon, Myanmar

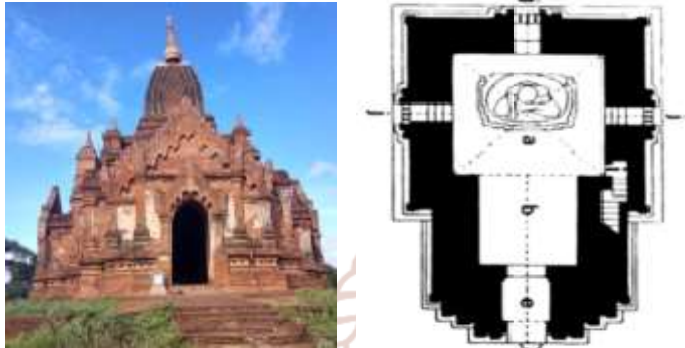
Figure.1. Temple type monument with central shrine

Temples are the common typology in Bagan. Based on plan configuration, temples can be classified as (1) temple with central shrine, (2) temple with solid core and (3) temple with central shrine and corridor. Based on Elevation, temples can be classified as (1) Single story temple (2) double or multi stories temple and (3) temple with continuous or discontinuous solid core. Stupas can be divided according to their plan configurations. Monasteries are one to two story monasteries. Most of the monuments were constructed in burnt clay masonry with mud or lime mortar. In some monuments, stone is used to reinforce the arch, wall and base but it is very limited. Reinforced concrete and steel member elements have been used for the 1975 post earthquake reconstructions and repairs of monuments. Physical, mechanical and chemical characterization of ancient bricks for selected temple type monument, stupa type monument, and monastery are shown in Figs. (1),(2), and (3) respectively.

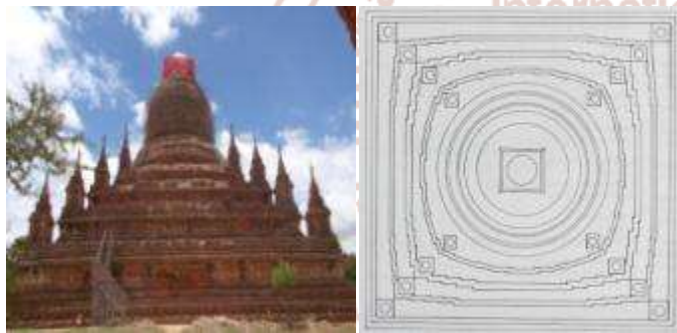
Figure.2. Stupa Type Monument

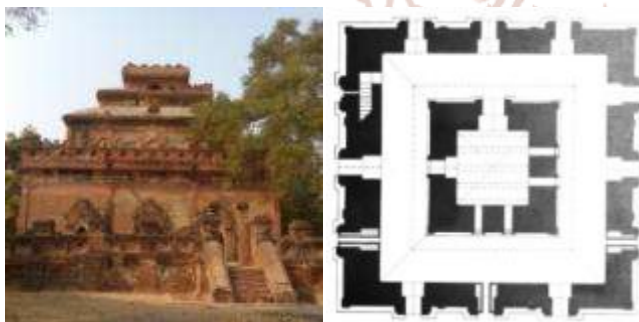
Figure.3. Monastery type Monument

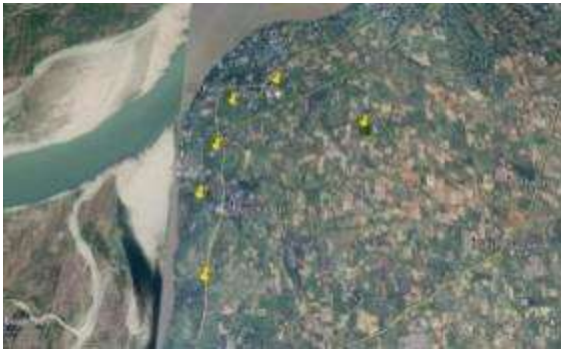
Figure.5. Location of Brick samples

Table.1. The collected ancient brick samples of monuments are located in Fig.5. Moreover, the new bricks from modern brick mill were collected in order to make the comparison of ancient and new bricks. The physical properties such as shape, size, color and density of the ancient bricks and modern bricks were studied. The mechanical properties of bricks such as crush test, flexural test and absorption test were experimented according to ASTM standards.

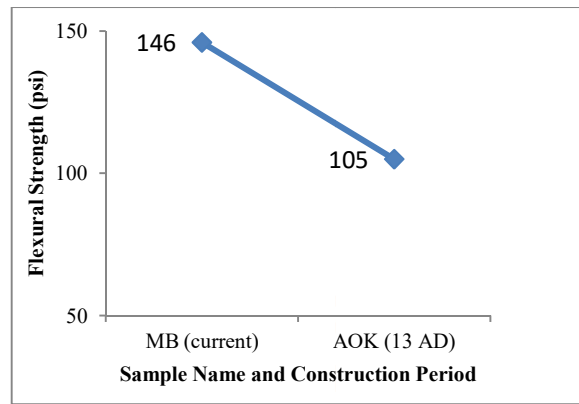
Figure.7 Flexural Strength of Ancient and Modern Bricks

From the crush test, the compressive strengths of the collected bricks are as shown Fig. 6. The range of the compressive strength varies from 339 psi to 2078psi. This can be seen that the compressive strength of ancient bricks is much higher than that of modern brick except from the result of Myaypon Thar Phayar Hla’s brick which is not certain whether ancient brick or reconstructed brick. The brick form Mingalar Zedi has the highest value because it is the original ancient brick. The flexural strength of ancient bricks was as good as nowadays bricks although they were subjected to weather affects and aging affects. The absorption rate of ancient brick was better than that of modern bricks. The comparison results are shown in Fig.7 and Fig.8.

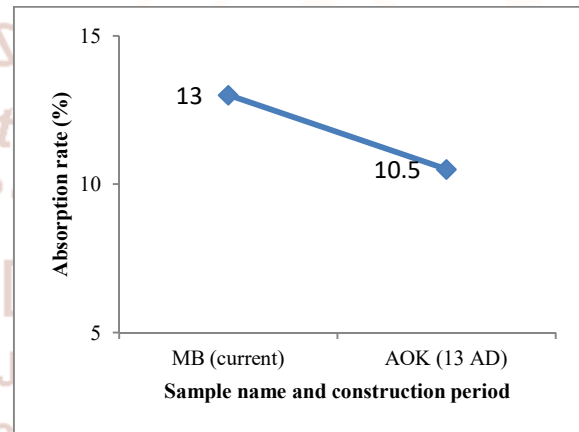
Figure.8 Absorption rate of Ancient and Modern Bricks

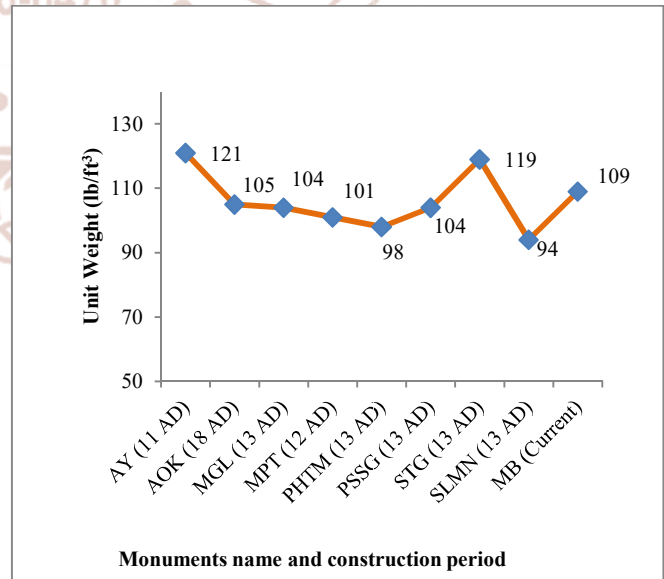
The various unit weights of the bricks are shown in Fig.9. the unit weight of ancient bricks varies from 94 lb/ft³ to 121 lb/ft³.

Figure.9 Unit weight of Brick samples

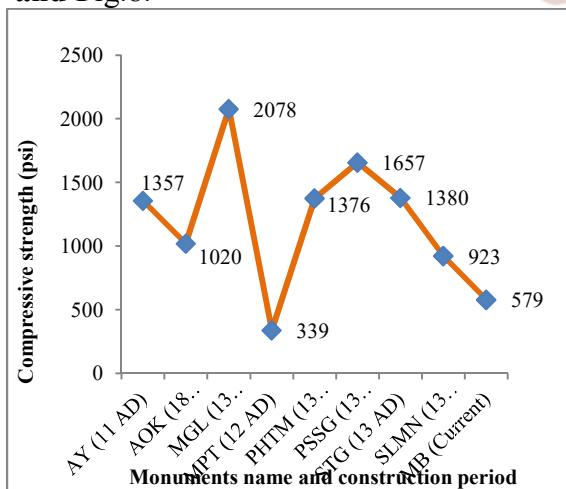
Figure.6 Compressive Strength of Brick Samples

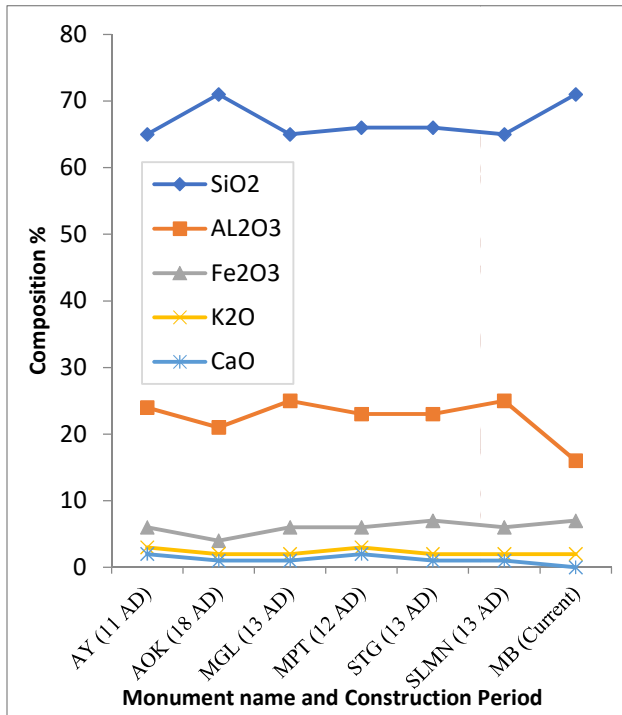
bricks. The results of most of bricks showed very high amount of silicon dioxide followed by aluminum oxide, iron III oxide and potassium oxide. The other compounds compound such as calcium oxide, titanium oxide, manganese oxide, chromium oxide vanadium V oxide, zirconium oxide, nickel oxide and strontium oxide are found as minor composition less than one percent. The EDXRF results of selected monuments are presented in Fig.10. It can be seen that the SiO₂ Content of modern brick is higher than that of ancient bricks and Al₂O₃ content of modern brick is lower than that of ancient bricks.

Figure.10 Chemical Composition Ancient and Modern Bricks

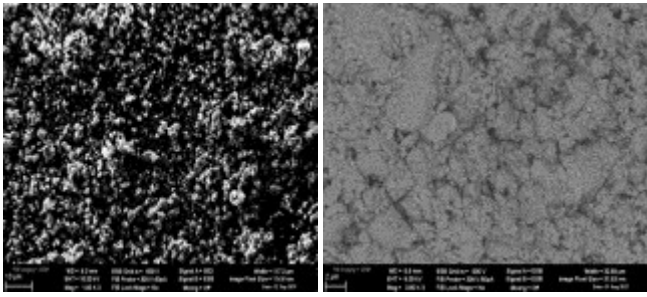
The investigations were carefully carried out on the sample to know the morphology of the surface and the elemental chemical analysis. The SEM image and BSE image of Ananda-Ok-Kyaung is shown in Figure 11. The elemental mapping of some area and 2 EDS microanalysis spots were carried out for chemical constituents. The elemental mapping of area analysis showed the presence of high calcium followed by magnesium, silicon and aluminum. The spots 1 was carried out on a grain and showed that the presence of highest value of calcium, magnesium, silicon and aluminum. The spots 2 was carried out on a dark matrix and showed that the presence of highest value of calcium, magnesium, silicon and aluminum and iron.

Figure 11 SEM and BSE image of Anan-da-ok-kyaung

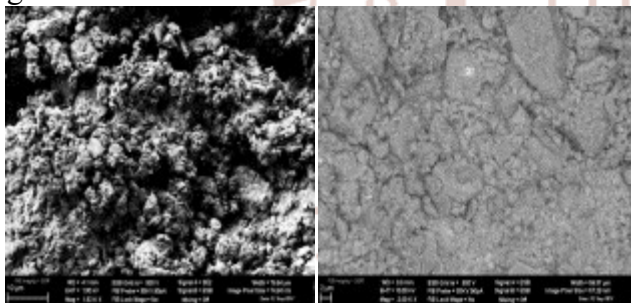
The SEM image and BSE image of the Sulamani Pagoda is shown in Figure 12. The elemental mapping of area analysis showed the presence of high silicon followed by calcium, iron, aluminum, magnesium and feldspar and albite. The spots 1 was carried out on a white color spot and showed that the presence of highest value of calcium, silicon aluminum and magnesium, The spots 2 was carried out on a dark matrix and showed that the presence of highest value of silicon, aluminum, feldspar and calcium and magnesium.

Figure 11 SEM and BSE image of Sula Mani
