Assessment of Stream Bank Erosion Hazard Potential through BANCS Model: A Case Study of Mahananda River at the foothills of the Darjeeling Himalayas

Pompi Sarkar

Dr. Deepak Kr. Mandal

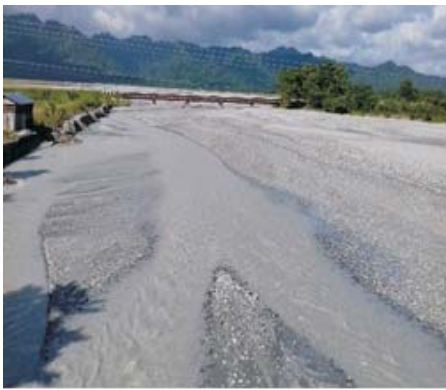
Plate-1: Formation of Longitudinal Bars on Channel Bed at Gulma region.

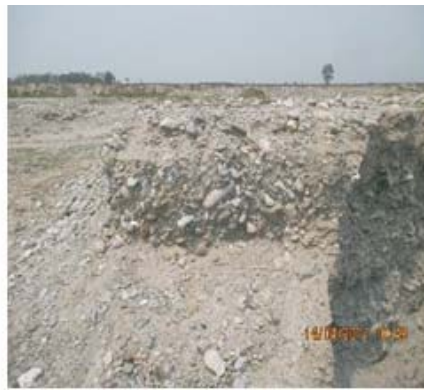
Plate-2: Riverbank mainly composed of sand, gravel, and pebble.

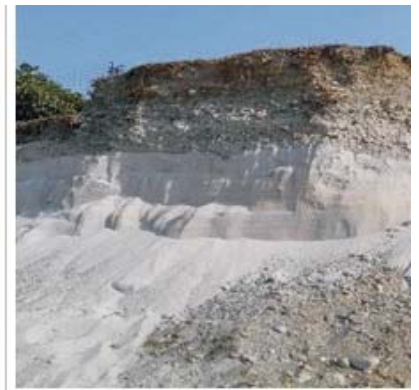
Plate-3: Exposure of very fine sand below coarse material.
