# REHABILITATION AND MAINTAINANCE OF ANCIENT BUILDING- A CASE STUDY OF SURGUJA DISTRICT

**Keywords:** Repair work, lime surkhi component, historical building, rehabilitation technique. Raghunath Palace, Circuit House, Kothi Ghar

**Cite this Article:** Aradhna Shrivastava and Vijay Kumar Shukla, Rehabilitation and Maintainance of Ancient Building- A Case Study of Surguja District, *International Journal of Advanced Research in Engineering and Technology*, 10(1), 2019, pp. 160-168.

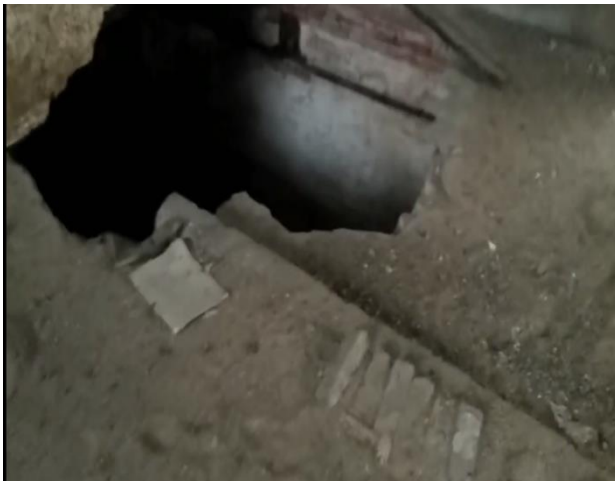
- I. **Damage to roof-** The roof of the building at various places got damaged as it is made up of brick and rested upon wooden girder. The white ants ate up the wood and made it empty from inside, moisture presence rotten up the wooden edges which were rested on the brick walls. And due to fire many of the wooden batten and purlins get completely damaged which in turn leads to falling of roofing materials. Bricks are laid vertically in between the batten as shown in figures fall off where battens were completely damaged.

The wooden beam at center portion are not destroyed but at end they have to bear the shearing force and destruction is due to sagging of beam which leads to copllaps of building as on wooden whole roof has been rested.

**Figure 1 a)** Roof damage at palace

- a) Remove the roofing materials without damaging the bricks and tiles of the roof and properly wash them if some unwanted materials get deposited over them. And stalk them separately.

- b) Change the batten, purlins, and wooden girders which are completely damaged by new ones keeping in mind the dimensions and type of wooden material used in the building. It is of sal wood.

- c) Properly seasoned and painted timber which should match the original colour should be placed.
- d) After placing appropriate wooden materials lay down the bricks over the batten with the help of lime mortar and apply lime mortar above the bricks to place the roof tiles which we have kept during removal of roof.

- f) New beam which we have to place on the end should be properly glued or scarfed with the older one which are still in good conditions.
- g) Jointing between the older and newly beam should be at a longer distance.

- h) For placing beam in the wall holes should be made and epoxy of lime mortar should be injected in the wall bore holes so that wood should be properly bonded with the mortar and is able to transmit the load. After hours of epoxies setting framed should be removed and then the surface is matched with the original one for final touchup.

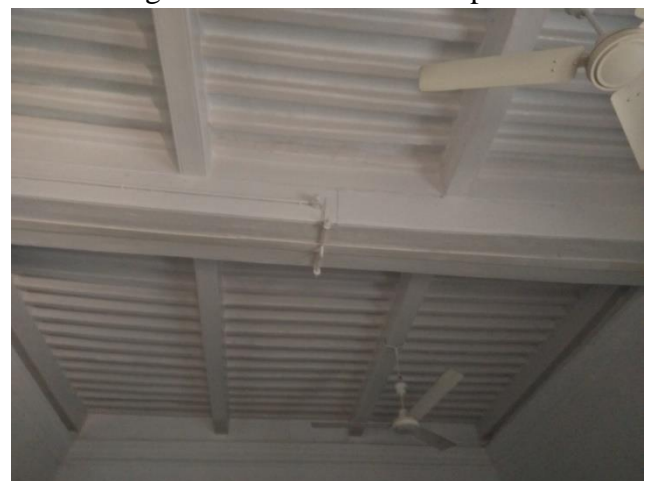
**Figure 1 b)** Repaired roof At Kothi Ghar

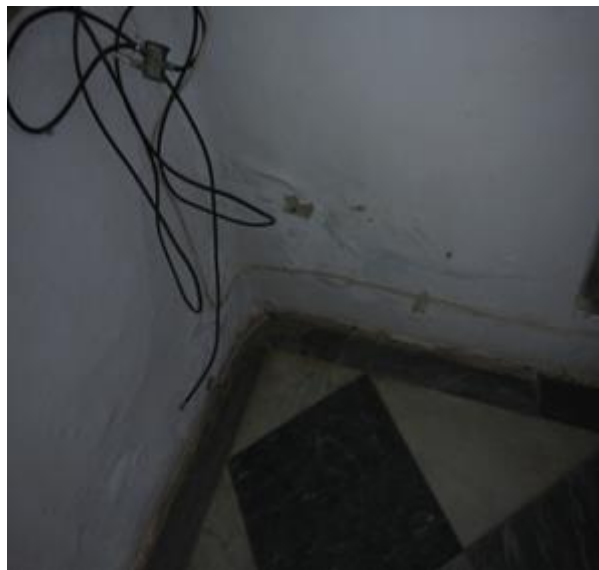
- II. **Settlement problem**-At the time of palace construction no one actual gave due importance to the soil bearing capacity. Because at that eras of construction people were unaware of such matter. At many places we have observed that the settlement of wall has occurred and sinking of soil beneath the wall leads to crack problem. These are due to poorly compaction of soil, moisture content or drainage leakage under the soil.

**Figure 2** Soil consolidation leads to Settlement

- a) First of all check the drainage and water leakage problem of the palace and repair if any present.
- b) Arrange proper disposal of rainwater which fall in the palace courtyard that it should not go inside the rooms.

- d) Peel of the floors where settlement issues are present and check out for bores or holes due to rats and any other animals if present. But before this support the corresponding roof with temporary column and support so that wall if required to be repaired at bottom will not affect the roof or superstructure.

- e) Properly compact the soil and remove all the agents which cause the settlement at that place and reconstruct the wall of palace as the walls are too wide more than 4 feet at plinth thus additional components are not required to support the walls.

- f) Mud jacking or grout pumping should be done if at any place soil is found to be expansive.
- g) Piling is required if complete foundation failure has occurred due to which hard strata will be constructed after boring holes and drilling in such a manner that vibration is nearly negligible. And then wall erection should be carried out.

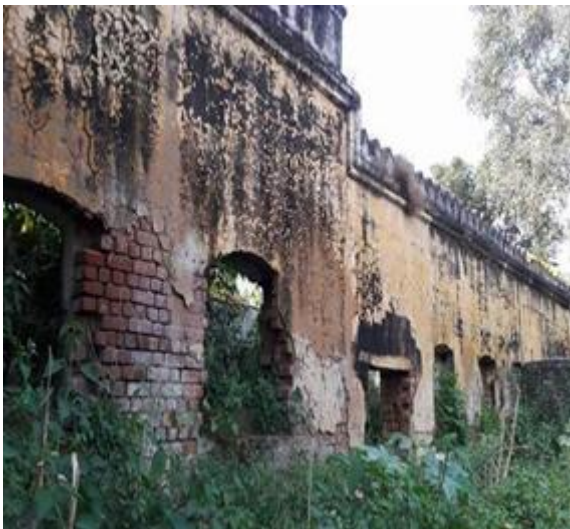
- III. **Damage to Walls-** at various places portion of wall gets completely felled of which slowly leads to brick deterioration as internal portion of wall get exposed to environment. Lack of care leads to collapsing of walls. At certain places small plant arises which disintegrate the bricks leading to wall failure.

**Figure 3 a)** Damages to External walls

- a) First of all remove the plaster and paint coating that is present over the damaged wall at about 2 feet and remove all the damaged bricks. Never use such brick for any other repair work because they have lost all its strength to moisture exposure and termite attack.

- b) After the removal of brick make lime mortar mixed with wooden apple and with the help of new brick complete the wall that is damaged by proper joining the existing construction and new construction.
- c) Lime surkhi mortar if possible to make then it is best as the structure is made up of same mortar and these in turn give good bonding strength between existing wall and new wall.
- d) After proper curing apply lime mortar plaster and do whitewashing by lime to get even shade as before.

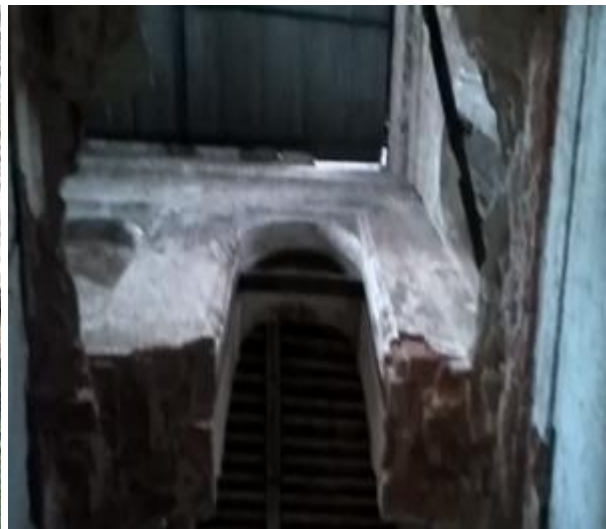
**Figure 3 b)** Roof and internal wall Damage

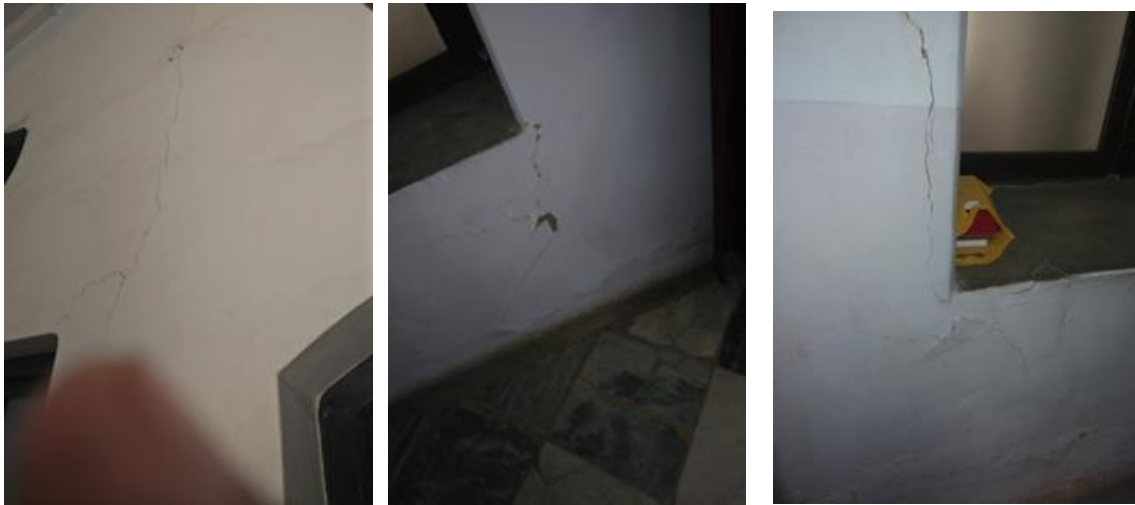
- IV. **Cracks**-certain cracks are only at the surface of wall that is only on peripheral portion that can be easily repaired but certain cracks are structural cracks which required utmost importance and should be repaired carefully. Hair line cracks are the defect due to less curing of structure component or due to not having proper bonding with the other component but major cracks are arises due to construction defect, sinking of foundation, or insect which make bore inside the wall and other component.

As the palace is load bearing and not concrete materials are used it has large sized walls which support the roof. At various places these wall get serious cracks at jointing area between roof and wall, girders and walls as girder rest on these heavy walls.

**Figure 4 a)** Hair line Crack      **Figure 4 b)** Crack due to Settlement      **Figure 4 c)** Structural Crack

- a) Remove and wash the plaster and painting over the walls and select those cracks which are structural in nature which require due importance of repair.
- b) Make hole by drilling all along the cracks lining and wash it off and allow it to dry.
- c) If it is not deep crack then use epoxy grouting or impregnation to seal the cracks. The epoxy should be of lime so that it can combine and create strong bond with the existing masonry layer in between walls.
- d) C- pins , U- pins or stitching will be used for deep cracks when we will require to provide tensile strength and it is should be used in places where cracks are wider and deeper.
- e) If there were plants uproot them and then remove the part of wall and reconstruct it by giving support to roof by heavy materials like steel girders etc, until wall has been repaired completely.

- f) For hair line cracks just remove that portion of plasters and paint and reapply the plaster with suitable lime surkhi mortar. And after proper curing apply two to three coat of whitewashing.

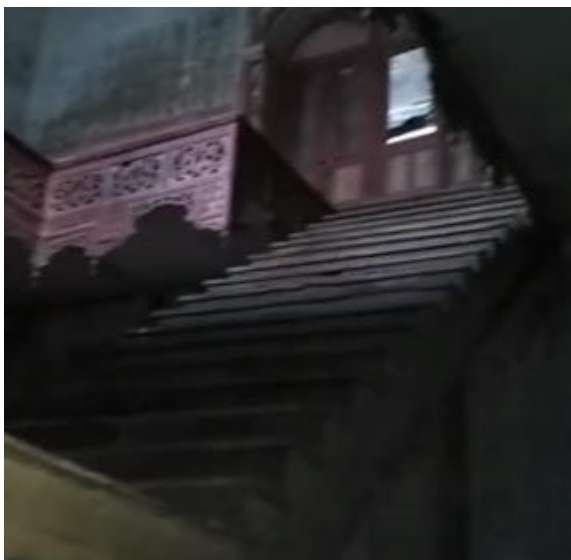
**Figure 5 a)** Stair case at Raghunath Palace

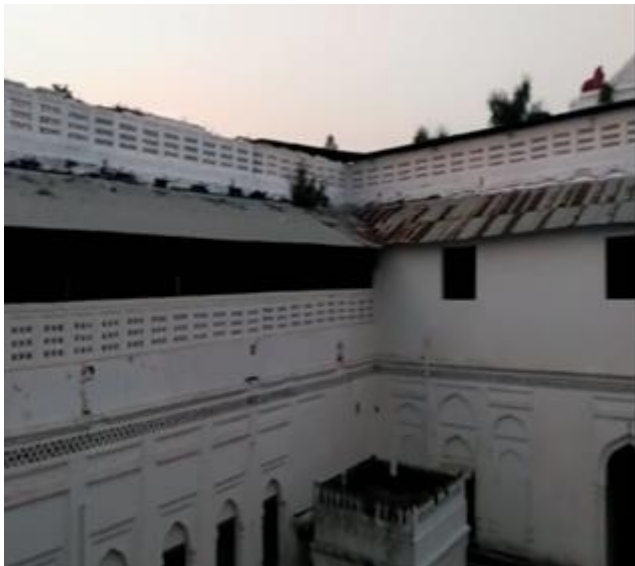
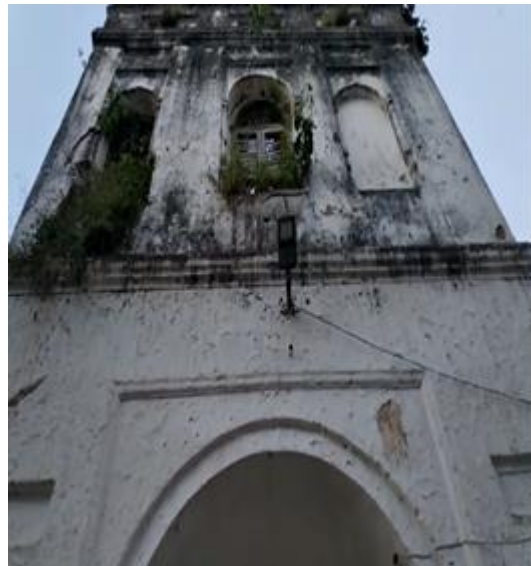
VI. **Biological agents and Moisture damage**- There are various types of biological agent which at particular seasons grow and after dying leave marks over the surface. These are even more worst then other destruction because many of has great impact on the structure. Plant growth their root interrupt the integrity of building as well as collapsing took place. Biological agent strain can be hardly removed by normal washing or cleaning so special treatment should be given to them.

**Figure 6 a)** Plant growth at the edges of roofs and parapet      **Figure 6 a)** Plants and algae attack

- a) First of all uproot all the plants and remove their roots.
- b) Apply salt on those areas so that root gets completely destroyed.
- c) Wash off the portion and then reconstruct the component with material they are made up of.
- d) Find the drainage and its route and unblock it by cleaning the path so that no future algal growth could take place.
- e) Use of bleaching agent along with soap solution should be done to clean the floor and walls at initial stage with high pressure. After the saturation of bleach scrub off the walls to remove the moulds and algae. And again wash it off to remove the rest of organisms.

- f) Any leaking of drainage should be closed properly so that water should not flow inside any of the rooms.
- g) Apply plaster repair and whitewashing to get perfect finish.
- h) Gyphosate, baking soda and vinegar, scrubbing and washing under high pressure should be used in order to remove the mosses. Fungi and algal growth.
