# Analysis of Flood Damage Assessment through WorldView-2, Quick Bird and Multispectral Satellite Imagery in Southern Punjab, Pakistan

Citation | Essa N.D., Amir M., Mahmood S.A., Riaz F., Farooq N., Rasheed R., Fatima S.Q., Batool S., Mehmood S.A., Kaukab I.S. Saeed. F. Analysis of Flood Damage Assessment through WorldView-2, Quick Bird and Multispectral Satellite Imagery in Southern Punjab, Pakistan International Journal of Innovations in Science & Technology, Vol 01 Issue 03: pp 120-139, 2019.

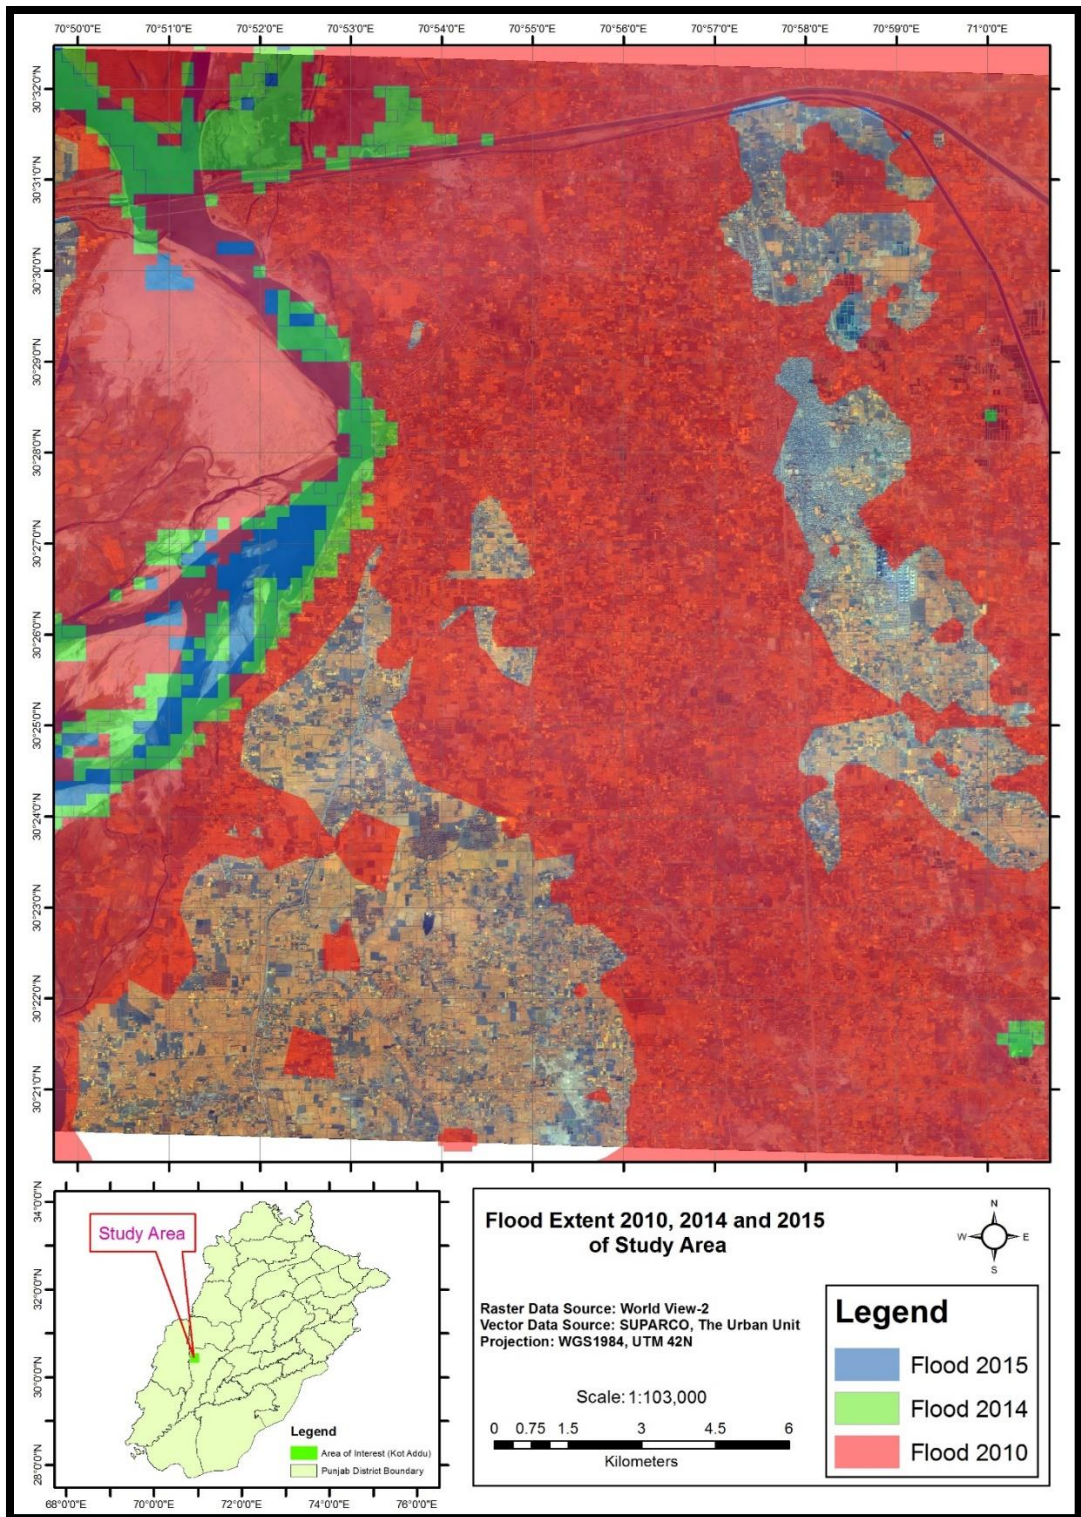
Figure 1: Flood Extent 2010, 2014 and 2015 in the study site.

Pakistan is struggling to manage natural hazards for survival from nastiest catastrophic conditions which may occur in future. About one fifth of Pakistan's area was affected by flood water in 2010 which pushed thousands of families to displace for their survival and leaving millions as homeless. The low-lying Indus belt in the Punjab Pakistan represents a flood prone zone. This flood hit the areas along Chenab and Sutlej River. It destroyed the existing infrastructure completely. Both the cultural and economic standards of life had been drained out in rain. Flood 2010 covered the complete study site in comparison to floods of 2014, 2015 as shown in figure 1.

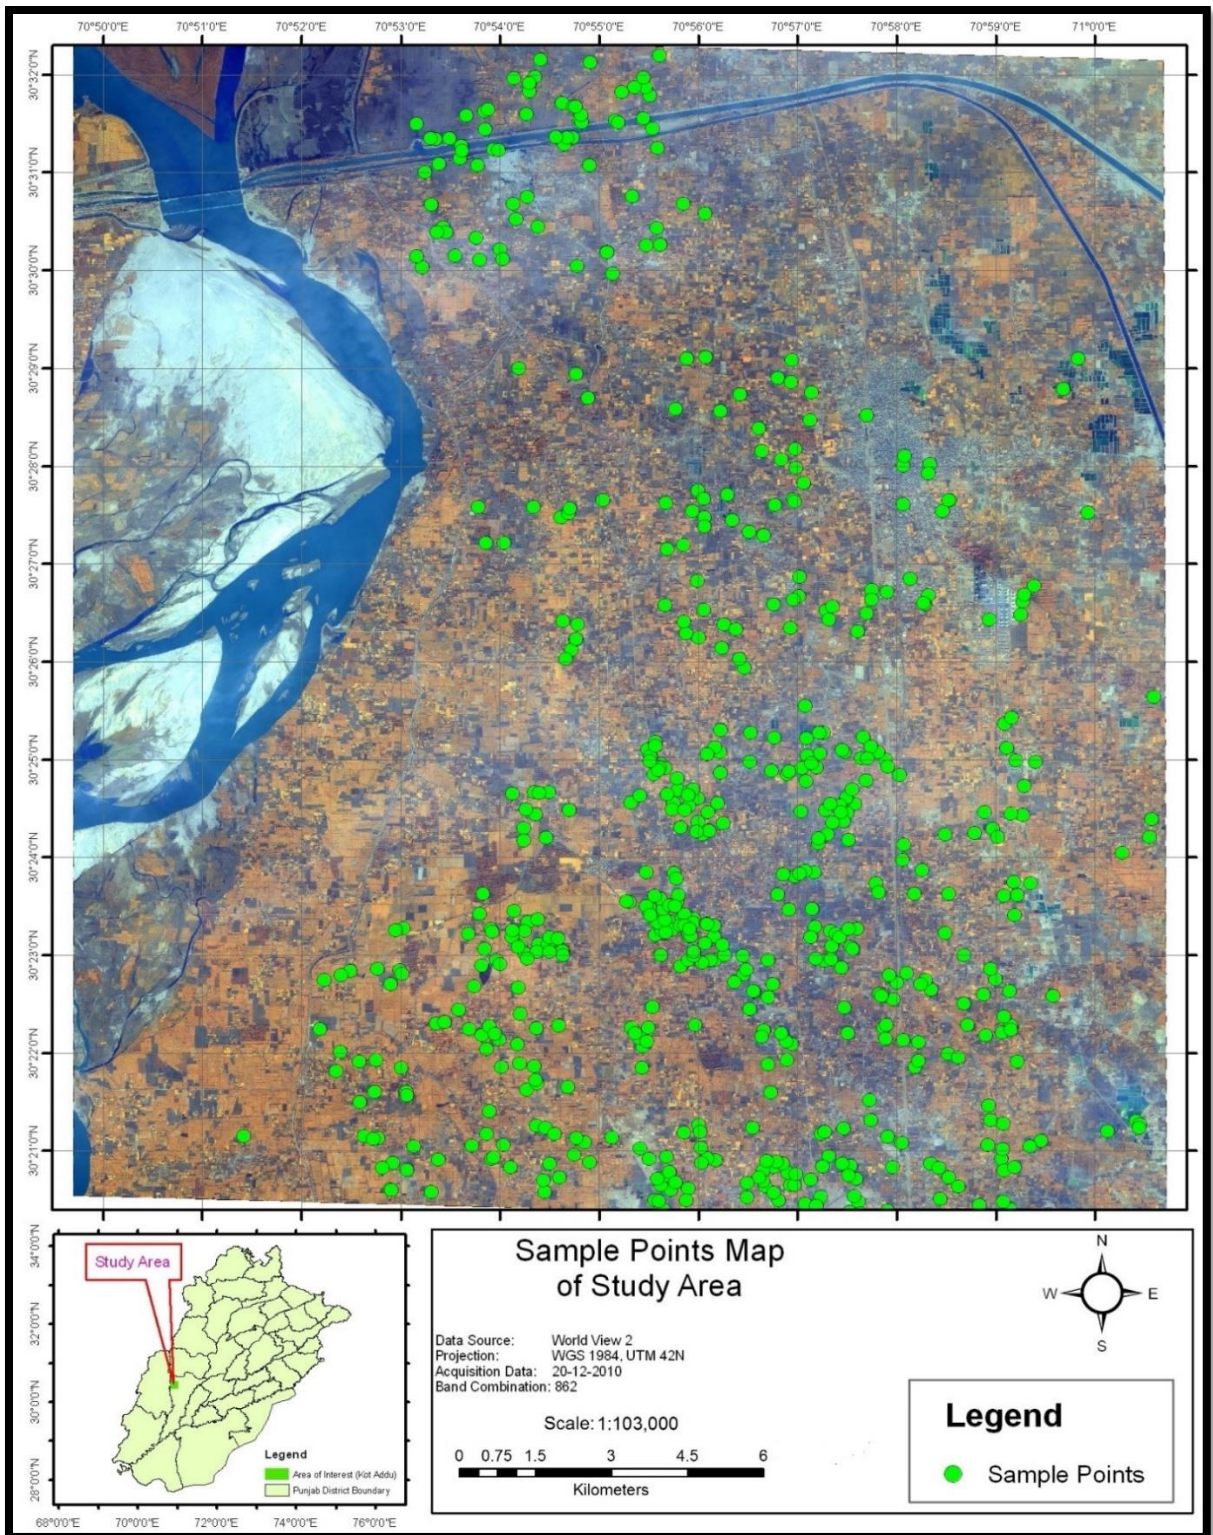
Figure 4: Training/Sample Points Map on the WorldView-2 Multispectral Image in FCC

The data was provided by the Digital Globe in patches. The mosaicking process was performed in Erdas Imagine to form a single scene of the WorldView-2 imageries. Moreover, the panchromatic image was diffused with multispectral imagery to get more clarity and high quality for visual interpretation. To identify the damaged features, visual interpretation technique is performed by using FCC on the multispectral 8-band imagery of spatial resolution 1.86m and compare with WorldView-2 panchromatic imagery of spatial resolution 0.46m, Quick Bird scenes of spatial resolution 0.6m along with digital photographs. About 170 categories of different LULC were identified using supervised classification on the basis of training areas and further recoded into 13 broad categories. GPS coordinates and the digital photographs of these damaged roads, drainage network, abadies, education institutes, health units, bridges, different kinds of agricultural and water areas were obtained during the field survey for verification of land use classification. The methodology flow chart is given in figure 3. The thematic map of training/samples points with WorldView-2 multispectral imagery is shown in the form of figure 4.

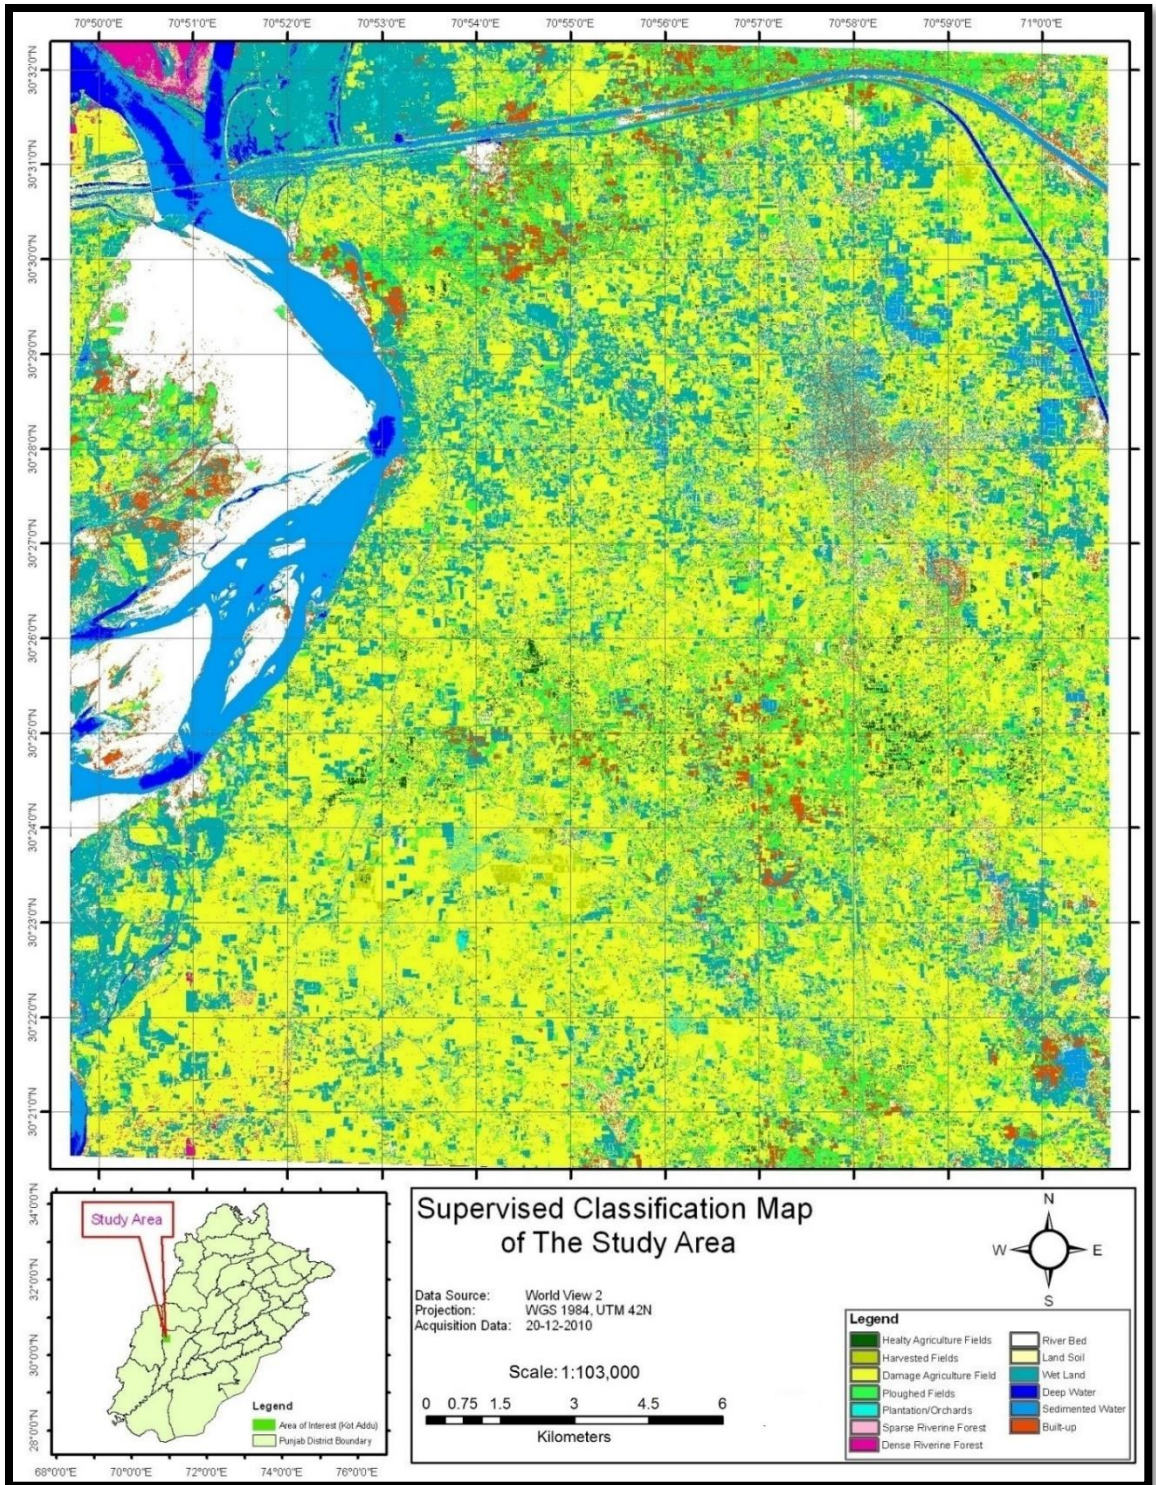
Figure 5: Supervised Classification Map

Supervised classification was executed with the help of the sample points which were collected during the field survey. By using coastal blue band, the deep water and the sedimented water is identified. Yellow and Red-Edge spectral bands have the major role in identification of different kinds of the agriculture field. Even by using NIR2 spectral band, the damaged agriculture field is identified which has the dominant area than the other classes. Riverine forest, sparse forest, plantation/orchards, land soil and built-up areas are also identified in the classification results. About 13 classes during supervised classification results are shown in the thematic map as in figure 5. The area wise detail of the 13 classes is shown in the table 3.

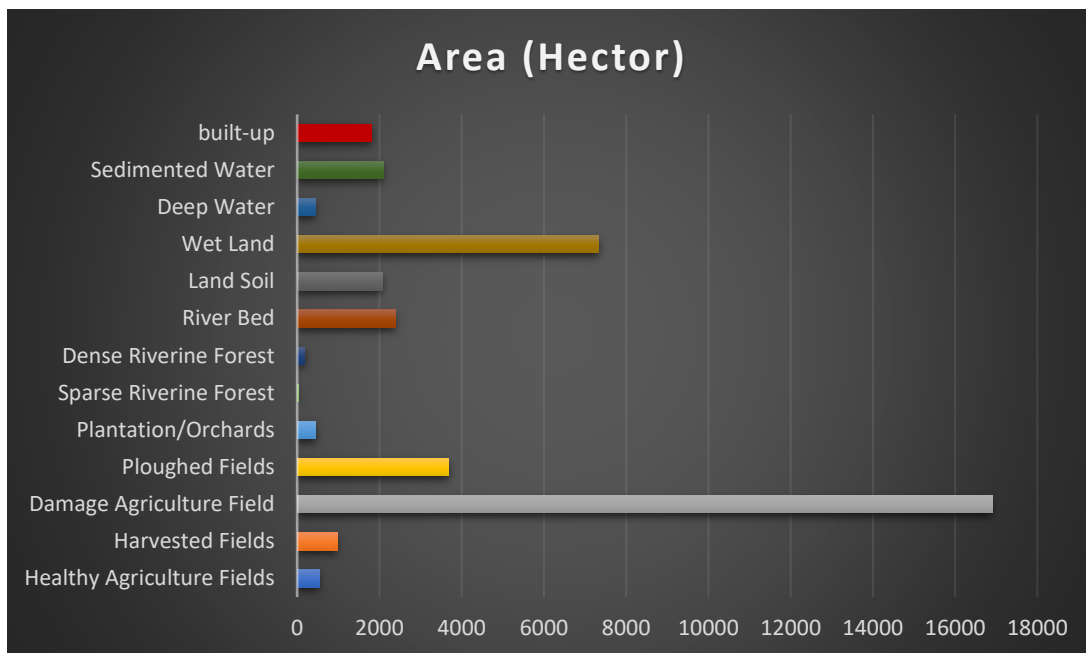
**Figure 6:** Supervised Classification Chart

Sr. No.	Class Name	Area (Hector)
1	Healthy Agriculture Fields	540.69
2	Harvested Fields	974.89
3	Damage Agriculture Field	16900.96
4	Ploughed Fields	3684.62
5	Plantation/Orchards	455.03
6	Sparse Riverine Forest	44.52
7	Dense Riverine Forest	190.34
8	River Bed	2385.81
9	Land Soil	2070.64
10	Wet Land	7330.79
11	Deep Water	440.79
12	Sedimented Water	2088.99
13	Built-up	1805.78
<b>Total</b>		<b>38913.87</b>

The result show that 16900.96 Hectors area out of 37108 Hectors was damaged agriculture land which is highest than the harvested field, healthy agriculture and ploughed field, while Sparse Riverine Forest has the area 44.52 hectors.

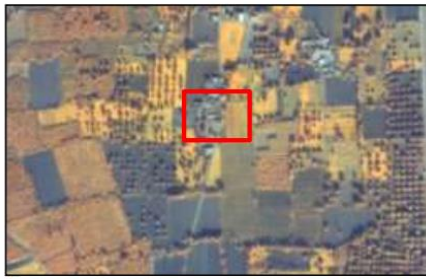
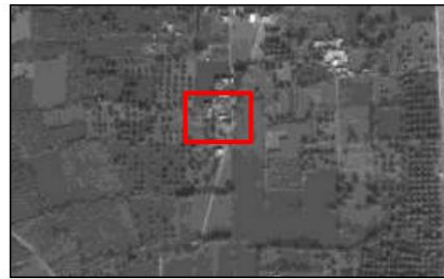
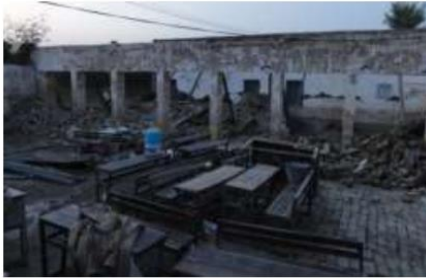
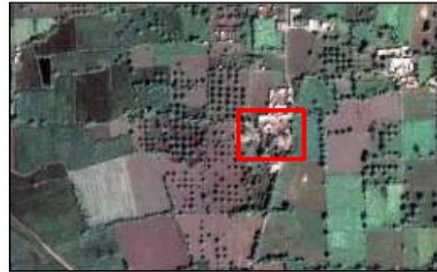
(a) World View-2, Multispectral  
Band Combination: 8, 6, 2  
Date Acquisition: 20-12-2010

(b) World View-2, Panchromatic  
Date Acquisition: 20-12-2010

(d) Quick Bird, 0.6m  
Date Acquisition: 21-10-2009

**Figure 7:** Damaged GGPS, Shauhrat wala UC 1 School Building is shown temporally in a, b, c and d

tangible damaged features; school, village, road, agriculture, bridge, and irrigation channel are shown in figures 6,7, 8, 9, 10, 11 and 12. The school is worst damaged during the flood 2010 as shown in figure 7 (a, b, c and d). Village is highlighted in the figure 8 (a, b, c and d), which is also badly affected during the flood 2010. The infrastructure was consist of; road, bridge and irrigation channel are also badly affected during the flood 2010. The significance of the flood can be seen in such kind of visual interpretations. The crops were badly affected in flood 2010 which is shown in the figure 10 (a, b, c, and d). The standing flooded water can be seen in digital photograph.

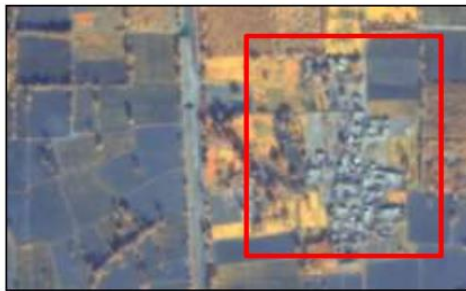
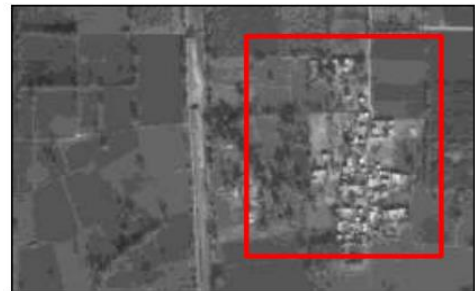
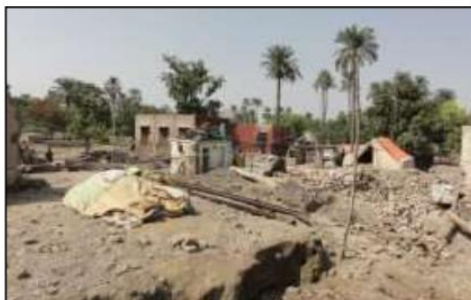
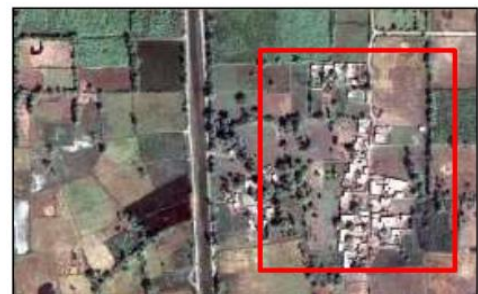
(a) World View-2, Multispectral  
Band Combination: 8, 6, 2  
Date Acquisition: 20-12-2010

(b) World View-2, Panchromatic  
Date Acquisition: 20-12-2010

(d) Quick Bird, 0.6m  
Date Acquisition: 21-10-2009

**Figure 8:** Damaged Basti Korai Wala is shown temporally in a, b, c and d and d

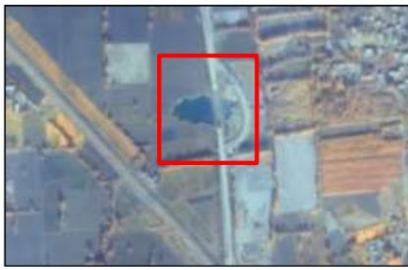
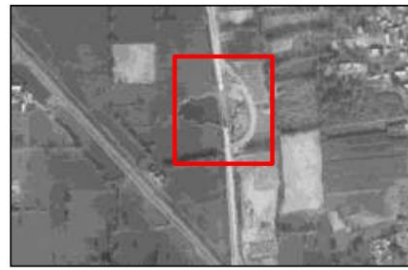
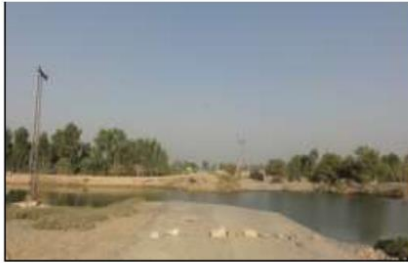
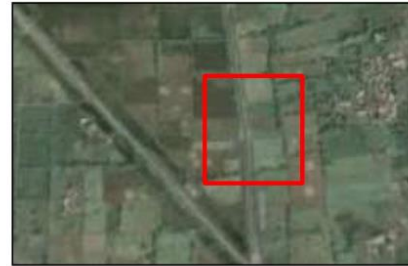
(a) World View-2, Multispectral  
Band Combination: 8, 6, 2  
Date Acquisition: 20-12-2010

(b) World View-2, Panchromatic  
Date Acquisition: 20-12-2010

(d) Quick Bird, 0.6m  
Date Acquisition: 21-10-2009

**Figure 9:** Damaged Taunsa Road is shown temporally in a, b, c and d

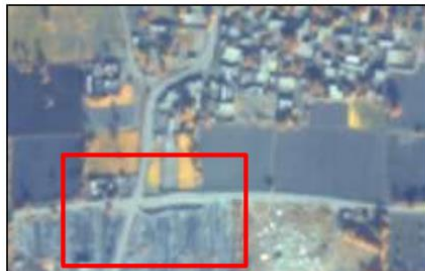
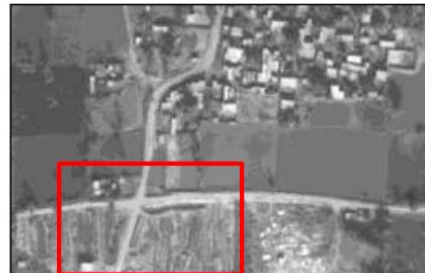
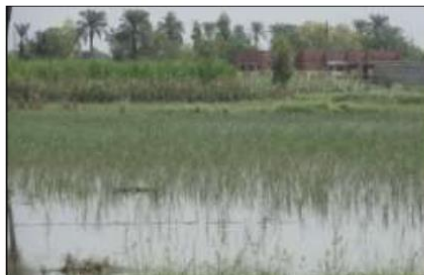
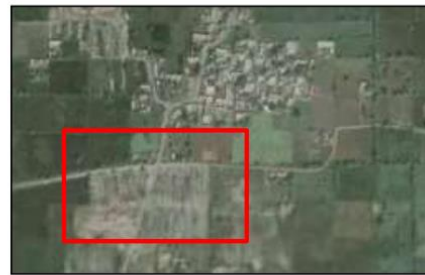
(a) World View-2, Multispectral  
Band Combination: 8, 6, 2  
Date Acquisition: 20-12-2010

(b) World View-2, Panchromatic  
Date Acquisition: 20-12-2010

(d) Quick Bird, 0.6m  
Date Acquisition: 21-10-2009

**Figure 10:** Damaged Agricultural at Haala village is shown temporally in a, b, c and d

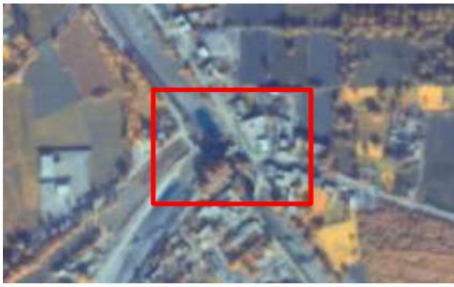
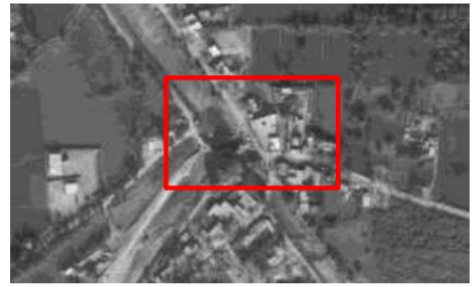
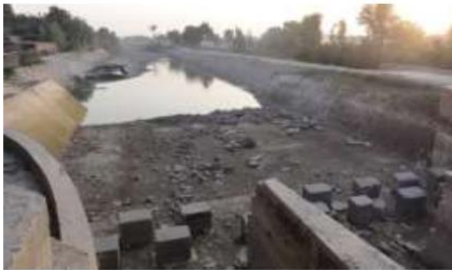
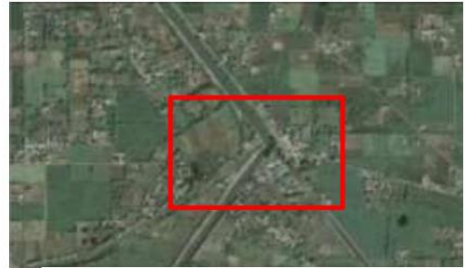
(c) World View-2, Multispectral  
Band Combination: 8, 6, 2  
Date Acquisition: 20-12-2010

(b) World View-2, Panchromatic  
Date Acquisition: 20-12-2010

(d) Quick Bird, 0.6m  
Date Acquisition: 21-10-2009

**Figure 11:** Damaged Bridge is shown temporally in a, b, c and d

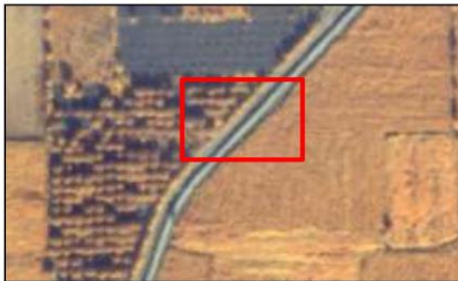
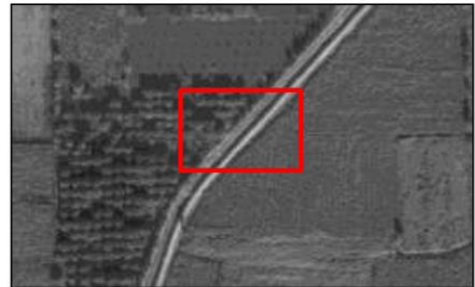
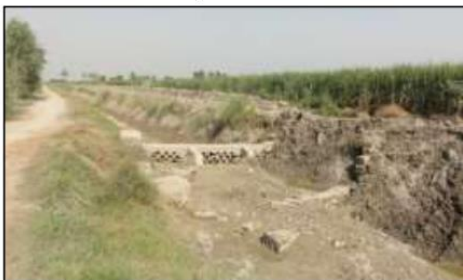
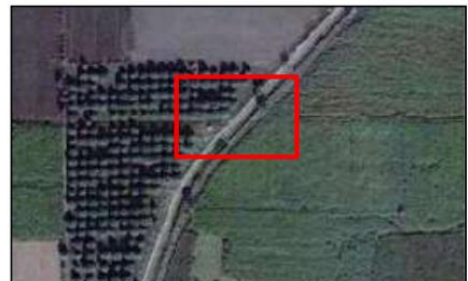
(d) World View-2, Multispectral  
Band Combination: 8, 6, 2  
Date Acquisition: 20-12-2010

(b) World View-2, Panchromatic  
Date Acquisition: 20-12-2010

(d) Quick Bird, 0.6m  
Date Acquisition: 21-10-2009

**Figure 12:** Damaged Irrigation channel is shown temporally in a, b, c and d
