## Case Report

## Huge calf swelling associated with a failed total knee replacement: A case report

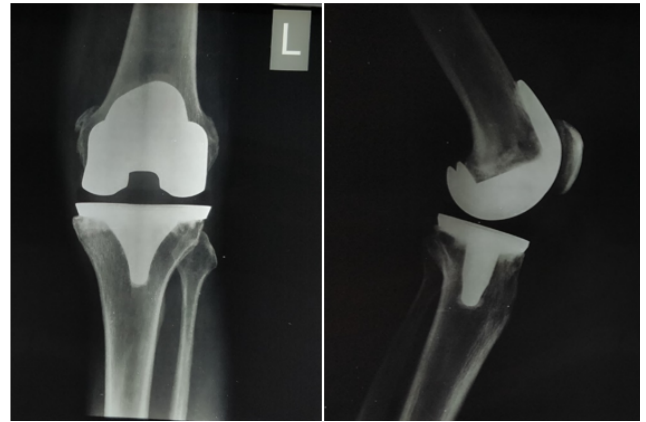
**Fig. 1:** Radiographs of primary TKA, taken 3 years back

A 75 year old male patient presented to us with complaints of a progressively enlarging swelling in his left calf region of three months duration. He had undergone left total knee arthroplasty (posterior stabilized, Exactech Optetrak prosthesis, Florida, USA) for tricompartmental osteoarthritis three years back (Figure 1). Three months ago, the patient noticed a small mass developing around his popliteal fossa with intermittent swelling of the knee joint. There was a progressive increase in size of the swelling. He experienced restriction in knee movements in the last one month following which he presented to us for evaluation. There were no constitutional symptoms.

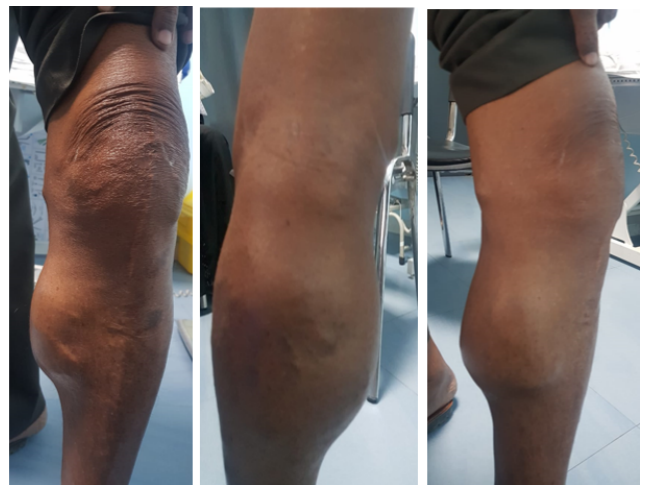
**Fig. 2:** Clinical photographs of left leg showing a huge swelling in the popliteal and calf region

On examination, there was a 20cm x 10 cm soft tissue swelling extending from popliteal fossa to the mid calf region of the left leg (Figure 2). The swelling was cystic with a smooth surface, non tender and non-pulsatile. Mild effusion was noted in the left knee joint without any

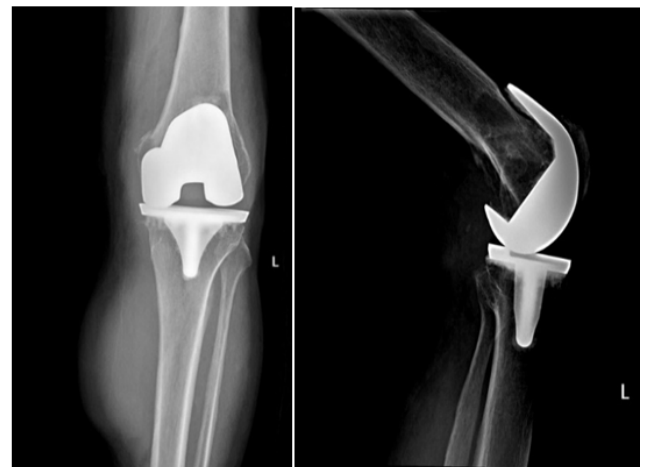
**Fig. 3:** Pre-operative radiographs show loss of joint space between femoral and tibial components, periprosthetic osteolysis on both distal femur and proximal tibia, along with a soft tissue mass shadow in the posteromedial aspect

signs of inflammation. Active knee range of motion was limited to 50 - 90°, with normal distal neurovascular status. Radiographs showed loss of joint space mainly on the medial side between the femoral and tibial components, periprosthetic osteolysis of the distal femur and a large soft tissue shadow in the popliteal and calf area (Figure 3). A doppler ultrasound scan ruled out deep vein thrombosis. An MRI scan revealed a large cystic mass of size 18cm x 9cm x 7cm expanding from the gastrocnemius-semimembranosus bursa and extending into the calf between the gastrocnemius and soleus muscles (Figure 4). Blood investigation showed a normal white blood cell count (TC=5000/ mm<sup>3</sup>), normal erythrocyte sedimentation rate (ESR= 5mm/hr) and C-reactive protein (CRP= 0.3mg/L) levels. The coagulation parameters were within normal limits. With the presumptive diagnosis of polyethylene lysis and aseptic loosening of femoral component associated with a calf mass, the plan was to proceed with a two stage procedure- 1) excision of swelling with microbiologic and histopathologic examination, followed by 2) definitive procedure after getting the lab reports.

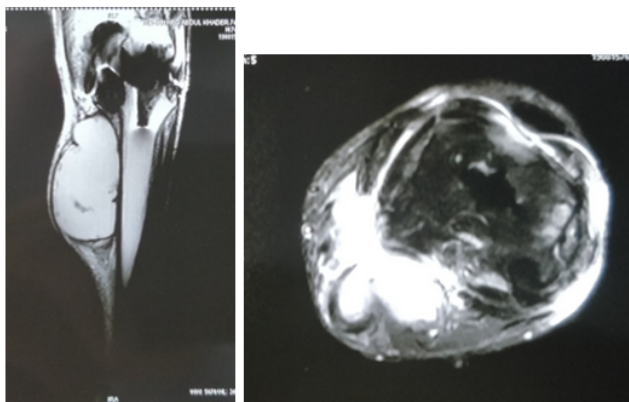
**Fig. 4:** MRI images of the left leg showing large cystic mass extending from popliteal fossa to midcalf, communicating with the knee joint

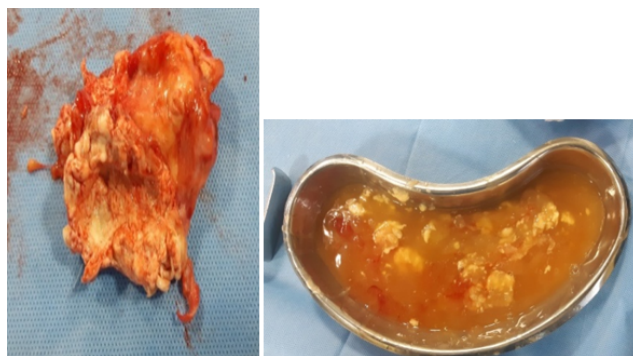
**Fig. 6:** Image showing (a): Cystic mass (18cmx9cmx7cm) excised from the leg, and (b): Turbid fluid containing coarse granules evacuated from the cystic mass

The cystic mass was approached through a posteromedial approach. Per-operatively, the cystic mass was communicating with the posteromedial knee joint (Figure 5). The mass was excised and it contained around 1000ml thick yellow fluid with polyethylene debris and necrotic material (Figure 6). Microbiological evaluation was negative and histopathologic examination showed multinucleated foreign body giant cells around refractile material without atypia, consistent with the picture of a tissue response to artificial joint implants (Figure 7).

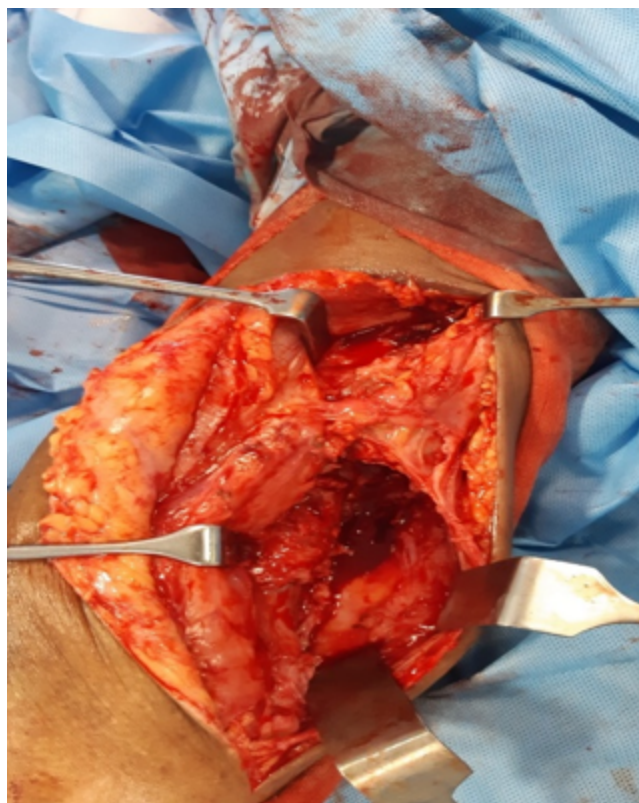
**Fig. 5:** Intraoperative photograph after excision of the cystic mass showing plane between the medial gastrocnemius and semimembranosus

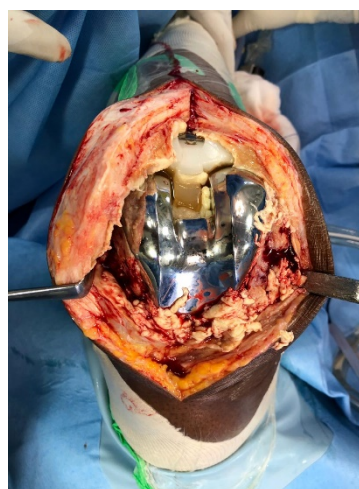
**Fig. 8:** Intraoperative clinical photograph during revision TKA showing hypertrophied synovium

After having an uneventful soft tissue healing, revision knee arthroplasty was performed through a medial parapatellar approach. Peroperatively there was extensive synovial hypertrophy without any metallosis (Figure 8). The polyethylene insert had gross pitting and delamination along with tibial post wear and backside wear (Figure 9). After extensive synovectomy, loosened femoral and tibial components were carefully removed. Extensive bone loss along with loss of integrity of medial collateral ligament was noted on the femoral side (Figure 10), for which a Distal femoral replacement component (LPS, Depuy Orthopedics, Warsaw, USA) was used and the tibial side bone defect needed a metaphyseal sleeve and stem with a MBT revision tray (Figure 11). There was uneventful postoperative recovery. At one year follow-up, there was pain free joint movements with range of 00–110°. There were no signs of cyst recurrence.

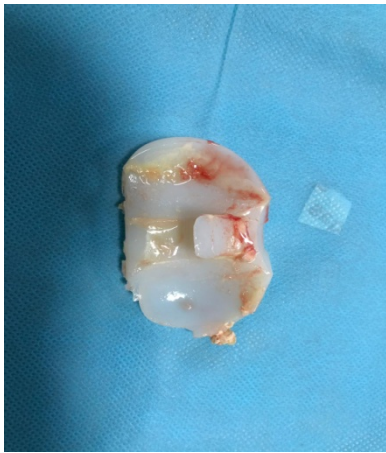
**Fig. 9:** Photograph of delaminated, worn polyethylene insert

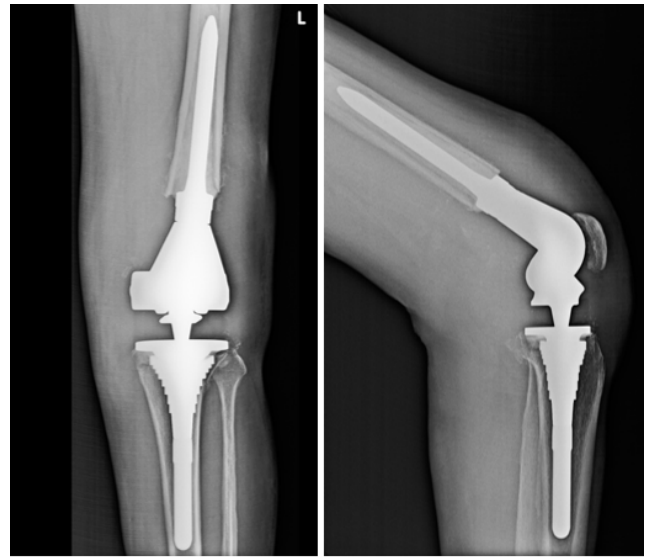
**Fig. 12:** Radiograph of left knee at one year follow-up

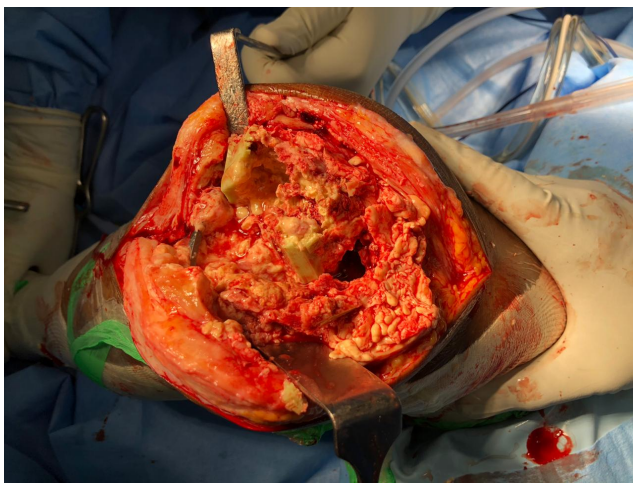
**Fig. 10:** Intra-operative photograph after extraction of components showing extensive osteolysis of femoral condyles

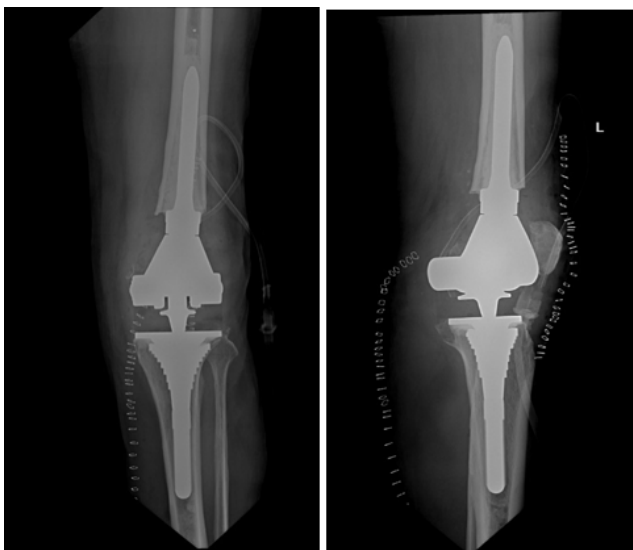
**Fig. 11:** Radiograph of left knee after revision TKA
