Riverbank Erosion & Consequent Land Settlement Issues: A Case of River Chenab, District Hafizabad

Citation | Aslam. R. M. S, Mayo. S. M, Ahmad. I, Ahmad. N and Arif. H, "Riverbank
Erosion & Consequent Land Settlement Issues: A Case of River Chenab, District
Hafizabad". International Journal of Innovations in Science and Technology, Vol 3, Issue 4,
pp: 152-165, 2021

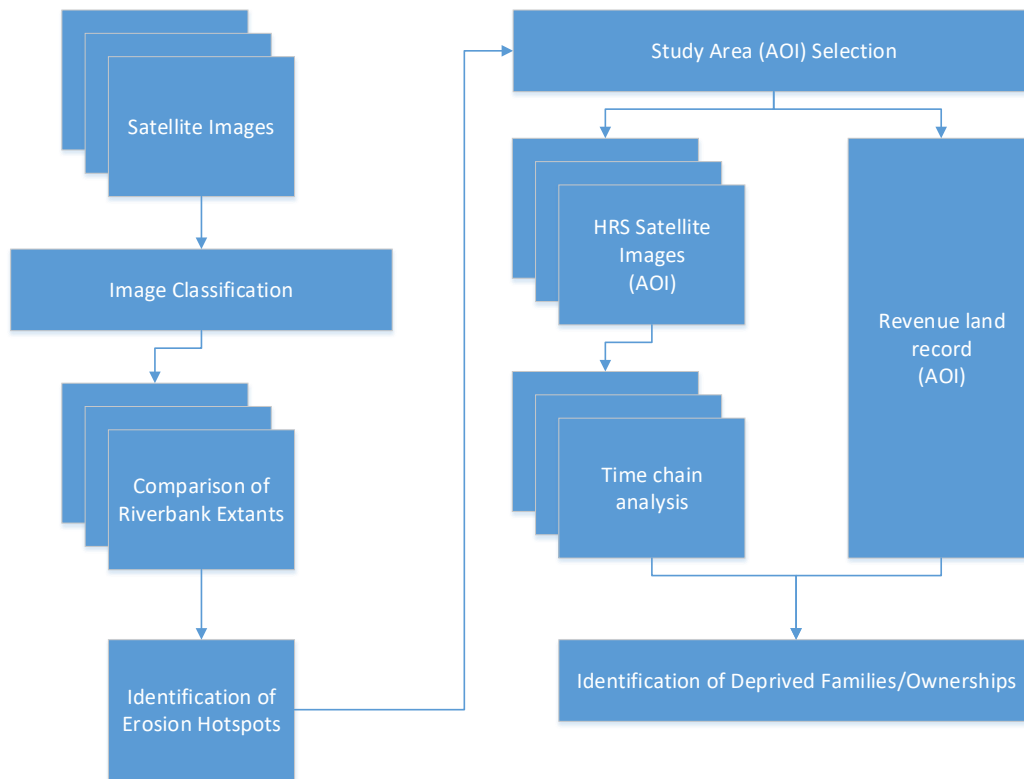
Figure 1. Flow Diagram

The riverbank change is a geomorphic and climatic agents' behavior that can be identified by studying its historic footprints. These geomorphic agents cause to erode the land on one side while causing deposition to form submerged land on the other side, higher deposition turns the water flow resulting in higher erosion to the mainland [5]. Higher water velocity causes higher riverbank erosion and its rate increases in the absence of vegetation as well [6]. Nowadays, there are different sources to study morphological pattern changes during a certain period at a certain location. RS is the best latest technique to study the river meandering in a more precise manner in a large region [7].

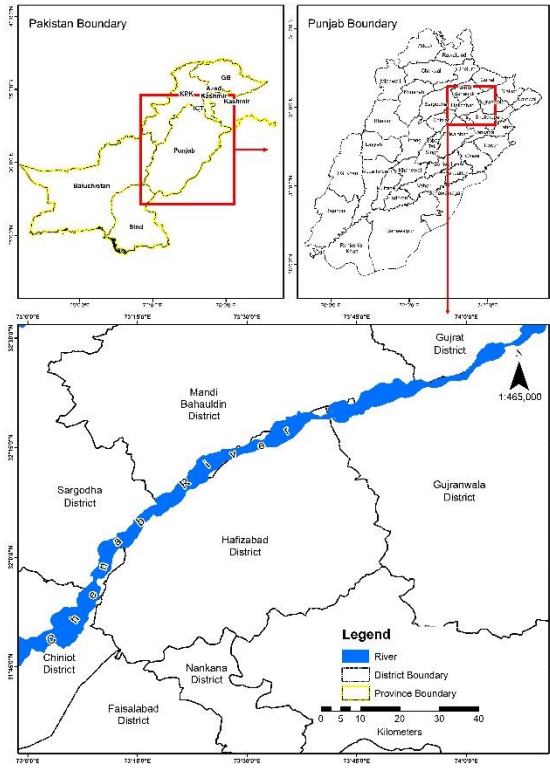
Figure 2. AOI of the Area

The Area of Interest (AOI) along the Chenab River inside District Hafizabad is highlighted with the red color rectangle in figure 2 below:

The study falls along the Chenab River within District Hafizabad. District Hafizabad is located at 32.07 N, 73.68 E in Punjab province of Pakistan. Its district boundary from North-East to South-West separates Mandi Bahauddin, Sargodha, and Chiniot districts along the Chenab River. The length of the Chenab River being hosted by the District Hafizabad is almost 67km out of the 101km long shared boundary with its aforementioned neighboring districts.

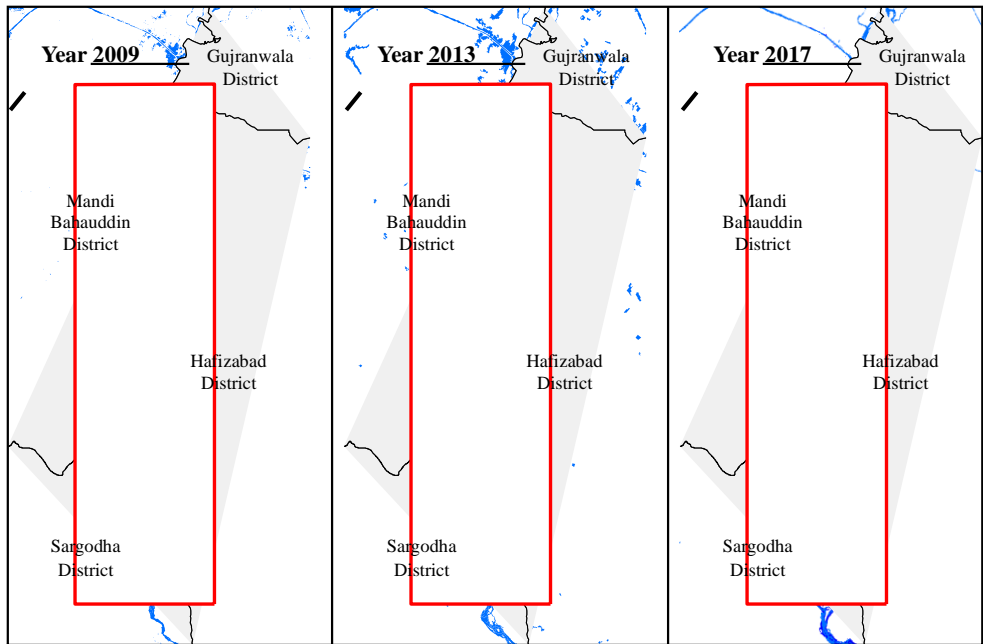
Figure 3. Chenab River channel course by the time
Riverbank extent comparison
 The comparative picture of all three years' results is shown in figure 4 below:

Object-Based Image (OBI) Classification technique has applied to aforementioned periods’ Landsat satellite images to find out the river course change occurred with the time frame.

The separate results of the Chenab river course observed for years 2009, 2013 and 2017 are as shown below in figure 3:

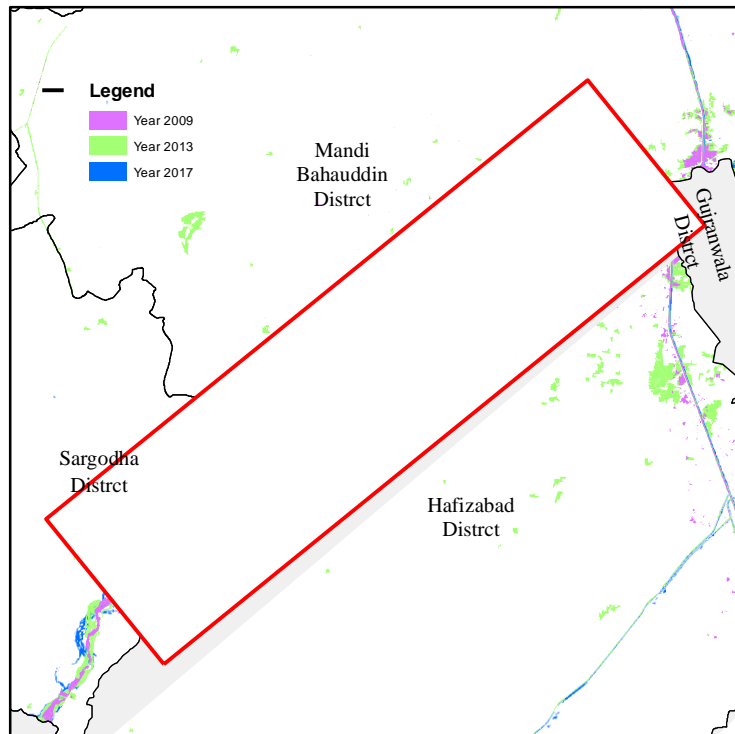
Figure 4. River course for years 2009, 2013 & 2017

Above, figure 4 is important to identify the hotspots in AOI where river course change may be more prominent with rapid change rate and helps to find valuable locations. RS and GIS are efficient tools for change detection [12]. For a layman, change in the river course is just morphological change but in reality, it disturbs the fertile land and leaves concerned families deprived. Riverbank erosion causes destroyed land, livelihood and eventually compelled the people to migrate [13, 14].

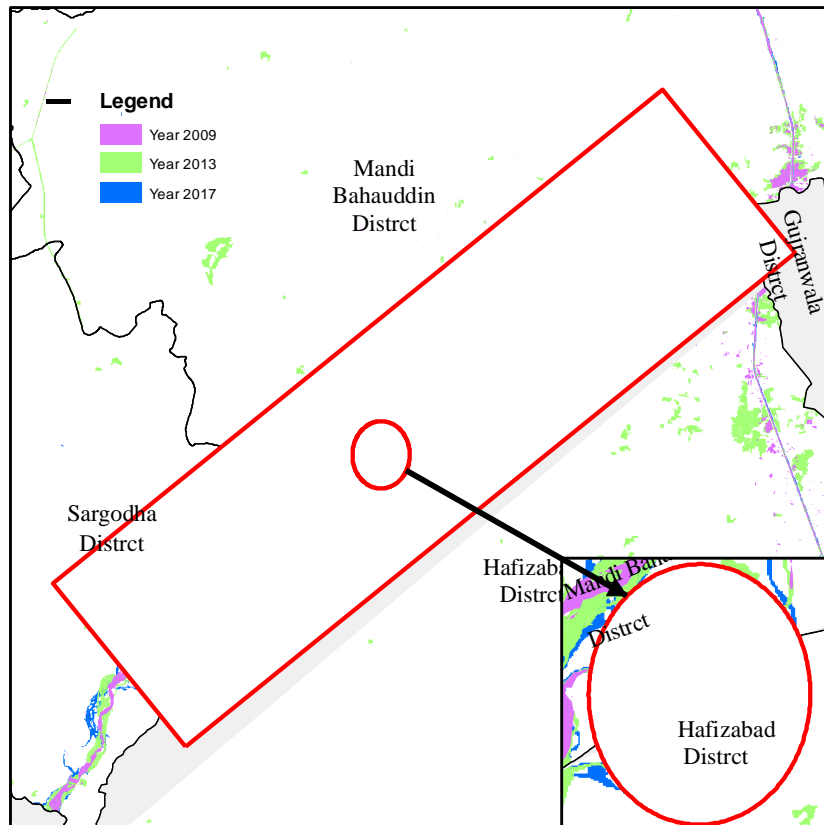
Figure 5. A selected hotspot for identification of deprived families

The fertile lands destructed by this phenomenon can be identified and such deprived families may be verified scientifically. This study will further focus on the identification of such deprived families through revenue records. For this purpose, there is a need to select one of the hotspots from our AOI as shown in figure 5 below:

River erosion is the process of changing river-bed and banks with the time passage. Erosion hotspots/vulnerable points are those locations where riverbank change is visible and it can be observed by comparing riverbank lines for at least two different periods. In figure 5 above, supports the identification of the river erosion hotspots. Here to proceed, only a single hotspot in District Hafizabad, “Chak Bhatti” along the Chenab River (left bank) has been selected for detailed working. This position is available at 73.39 E, 32.16 N.

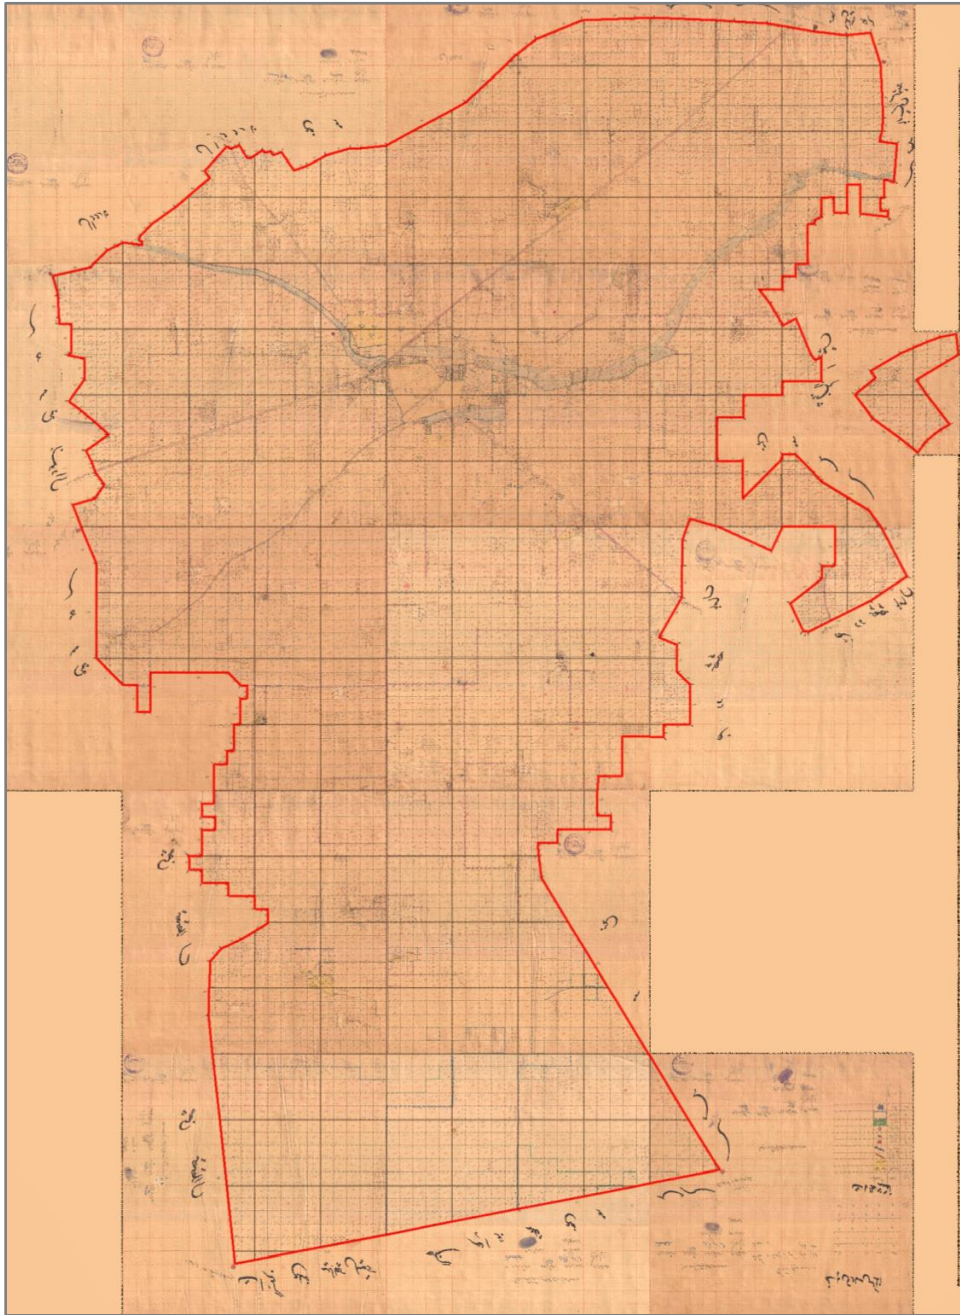
Figure 1. Massavi map (revenue record) of Chak Bhatti, District Hafizabad

For precise identification of deprived families due to river erosion phenomena, there is a need to register the revenue land record document (Massavi map, contains individuals' land ownership information). It is possible to make geo-referencing of Massavi map, applying the GIS techniques [15,16]. For the said purpose, the Massavi map of "Chak Bhatti" (shown in figure 6 below) can be geo-tagged and the processed Massavi map results are shown in figure 7 below:

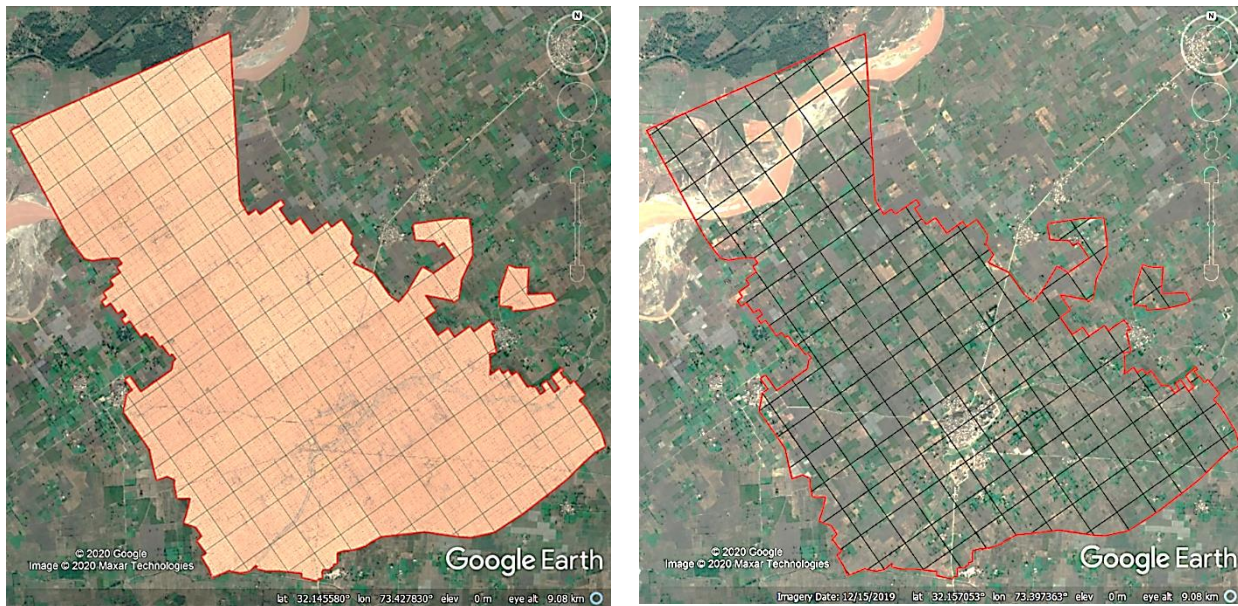
Figure 7 and figure 8. are showing comparative pictures and ground linear features can be matched easily for evaluation as well.

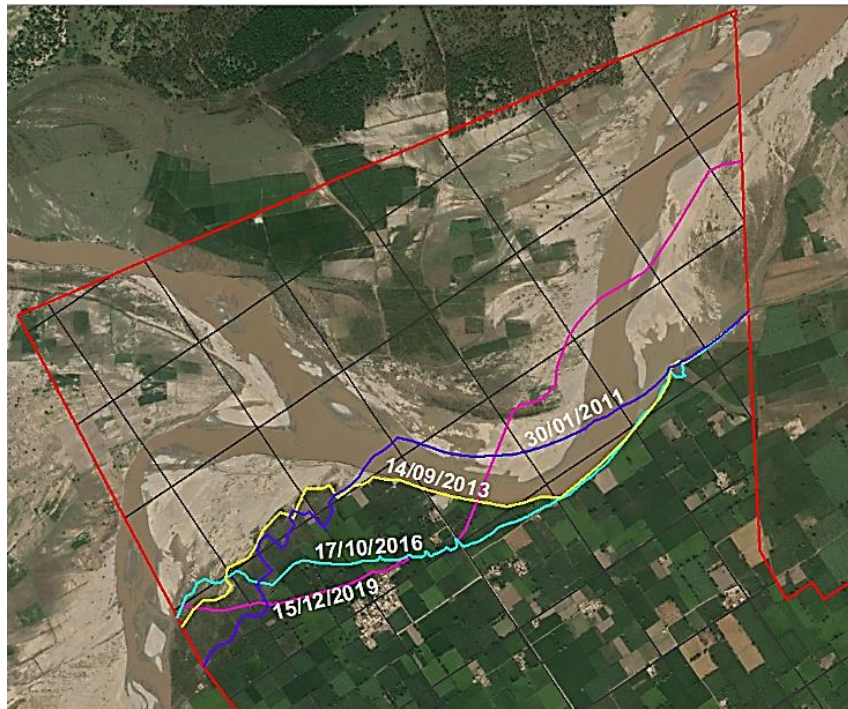
Figure 13. All time riverbank shifts' comparison

A complete comparison of all time riverbank shifts has (separately shown above in figure 9, 10, 11 & 12) displayed in figure 13 below:

Figure 13 shows that how the riverbank is eroding land with time, it also shows that riverbank displacement from 2013-16 is more than any other span which reflects the effect of 2014's super flood faced during this period. The joining points of riverbank displacement lines between 2013-16 and 2016-19 show 448m and 162m shift in South-West along with the river flow, respectively. This shows that the average riverbank displacement due to erosion phenomenon at this location was 12.1m/month and 4.4m/month during 2013-16 and 2016-19, respectively. The victims face economic, social and health insecurities and make families' life more vulnerable [20], however, regular monitoring of riverbank erosion values and soil degradation can help to foresee the situation [21]. Families settled along the riverbank used to face many problems in their daily life due to issues like frequent floods and riverbank erosion [22]. On the other hand, bad governance also acts as a catalyst for the miseries of the affected community [23]. Therefore, it is needed to monitor the erosion phenomenon on regular basis to save the vulnerable communities otherwise it may turn to serious consequences as well [24]. Many remedial measures may be taken including concretization, plantation, desilting, use of nut-fibers and synthetic erosion-resistant mats [25]. Soil can be divided into different types based on erosion rate and accordingly plantation plans can be suggested, like land with heavy grade erosion can be planted by sugarcane and with low grade erosion can be corn or rice [26].

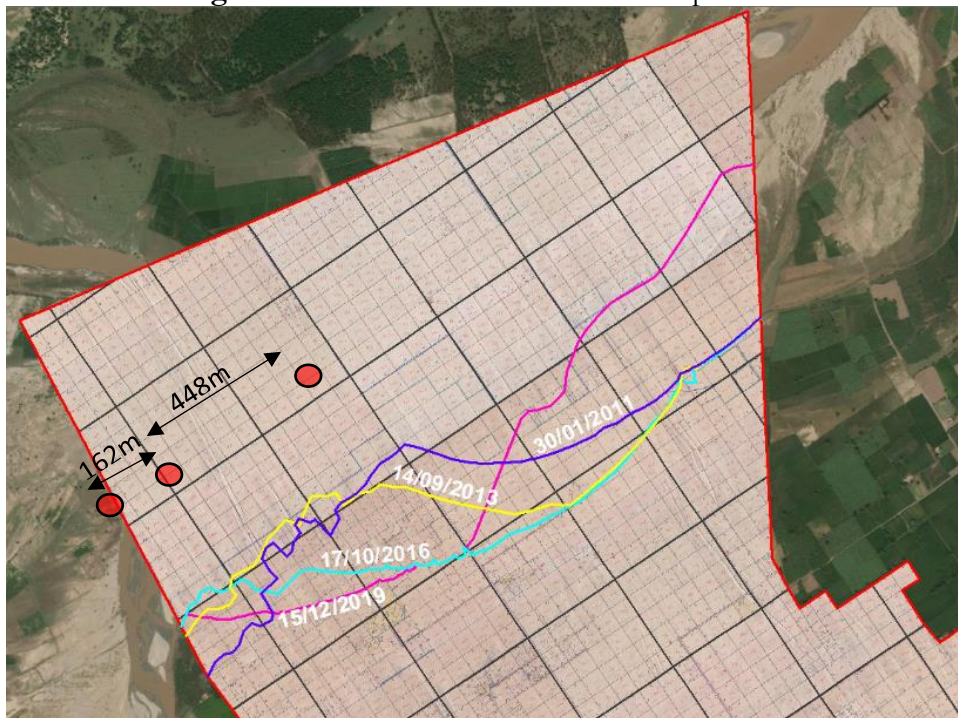
Figure 14. All-time riverbank shifts along with Massavi map (revenue record-keeping document)

the affected landowners. Figure 14 is self-explanatory to identify such ownerships as geo-referenced revenue land record has shown with the time-to-time riverbank displacement extents which geo-tags all the affected ownerships very precisely. This study at work has multiple benefits in the larger disaster management realm, but more specifically it is highly useful in:
