## CASE REPORT

### ESTHETIC REHABILITATION OF SEVERELY DECAYED PRIMARY INCISORS USING GLASS IMPREGNATED FIBRE POST AS POST AND CORE: A TREATMENT OPTION

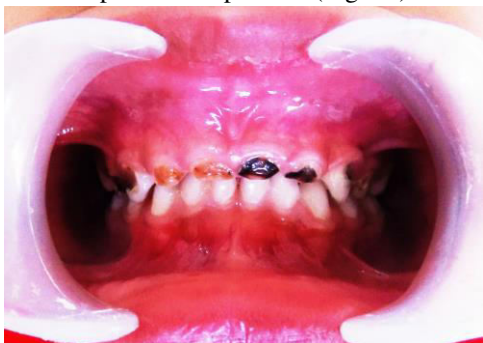
On clinical examination 51, 52, 61, 62, 53, 54,55, 63, 64, 75, and 85 were carious. The remaining tooth structure of maxillary anterior teeth were found to be firm, with an extension of the remaining crown of 1 mm above the gingival margin (Fig. 1). The treatment plan was explained to the child's parents along with, its advantage and drawbacks, other treatment option and consequence if treatment was not carried out.

Figure 1: Preoperative intraoral photograph frontal view

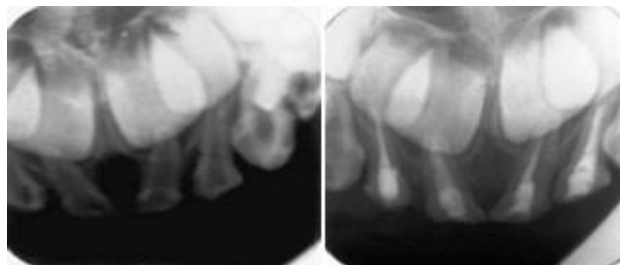
Figure 2: Preoperative and Postoperative intraoral periapical radiograph of 51, 52, 61, 62.

In first visit all the active carious lesions were restored with GIC. Gross carious lesions were removed with a no. 330 round carbide steel bur. The pulp chamber was opened & for working length determination Intraoral periapical radiograph was taken, pulp tissue was extirpated using K-files(Mani INC, Tochigi, Japan). After copious irrigation, the root canals were dried using paper points. A thick mix

of zinc oxide eugenol paste (Deepak Enterprise, Mumbai, India) was then condensed with hand pluggers (Mani INC, Tochigi, Japan) into the canal(Fig. 2) by careful isolation using cotton rolls and saliva ejectors as teeth under treatment do not had enough crown structure for rubber dam application.

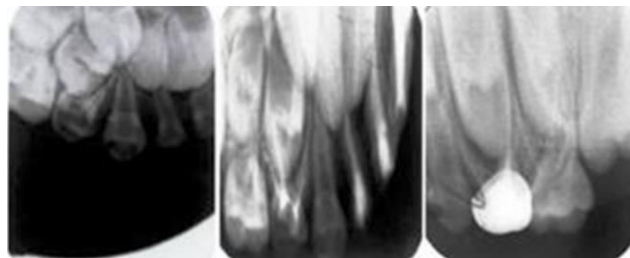
Figure 3: Preoperative and Postoperative intraoral periapical radiograph of 54

Endodontic treatment of 54 and 64 were completed in subsequent visits followed with GIC (Fuji 2, GIC Corp, Tokyo, Japan) restoration and stainless steel crown (Kids crown, Shin Heung, Republic of Korea) (Fig. 3 &4).

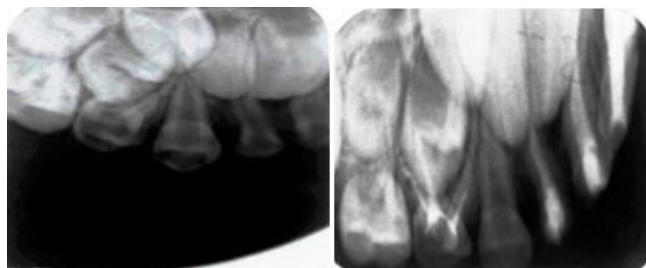
Figure 4: Preoperative and intraoral periapical radiograph of 64

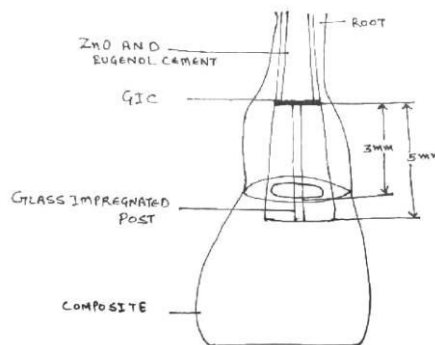
Figure 5: Figure of plan for construction of restoration.

The post space was prepared in anterior teeth during second appointment by removing approximately 4 mm of Zinc oxide eugenol (Deepak Enterprise, Mumbai, India) material using slow moving thin straight fissure bur and post space radiograph was taken. A 1 mm base of glass ionomer cement (Fuji 2, GIC Corp, Tokyo, Japan) were placed to isolate the obturated material from the rest of post space (Fig.5). GIC sticking to walls of root canal was removed using sharp spoon excavator. For each canal a glass fiber post (Interlig, Angelus Brasil) (Fig. 6) of corresponding size was trail fit and adjusted to 3 mm into the canal and 2 mm outside the canal by measuring the post length upto 5mm. Prepared cavity was acid etched for 15 sec with a 37% phosphoric acid gel, rinsed, dried and two coats of a dentin adhesive single bond (Adper™, 3M ESPE) were applied with micro brush. The tip of flowable composites was placed 2-3 mm below the CEJ and the composite was injected. The glass post was inserted into the canal and light cured. The coronary portion of the fiber post was completely restored using resin composite(Fig.7). After checking the occlusion and the removal of any occlusal interference, final finishing and polishing of the restoration was performed thus restoring a new smile of the child (Figs.9). Following completion of restoration of 51,52,62and 62 intra oral periapical radiograph was taken(Fig. 8). Fluoride varnish therapy was also given, along with dietary counseling, care of the restorations and importance of maintenance of good oral hygiene as well as the importance of periodic dental visits (3,6,12 months follow-up) for preservation of the primary dentition was described to the patient and parents. (Fig. 10)

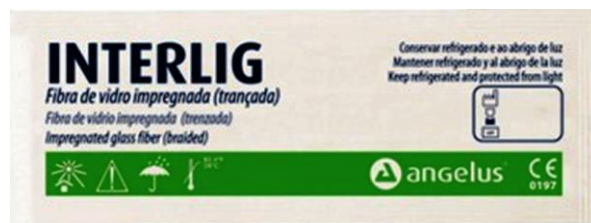
**Figure 6:** Glass impregnated post used

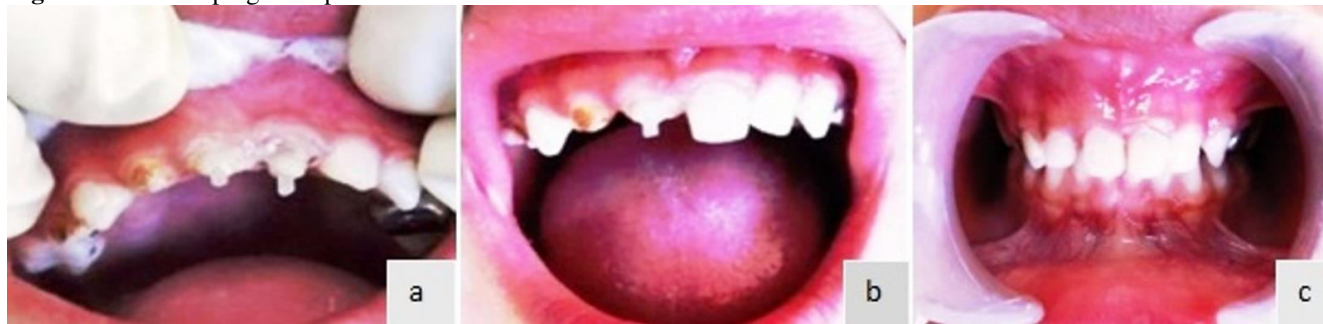
**Figure 7:** Placement and curing of Glass impregnated post into root and esthetically completed restoration canals

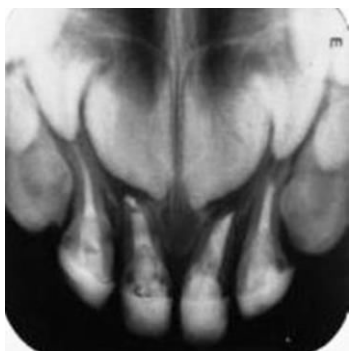
**Figure 8:** Postoperative radiograph after glass post insertion of 51,52,61,62.

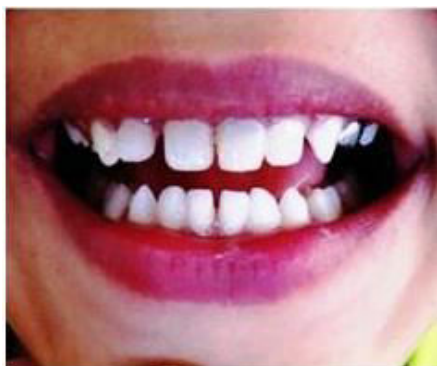
**Figure 9:** Esthetic smile of the patient established

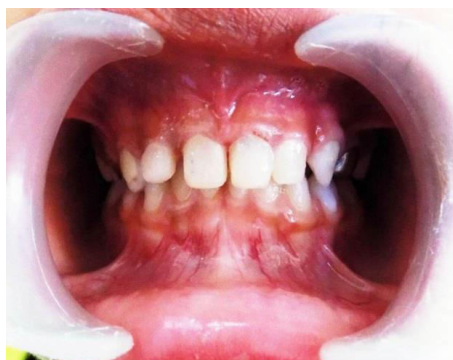
**Figure 10:** Esthetic smile of the patient 6 month follow up
