FUNGAL DETERIORATION OF MONUMENT WITH REFERENCE TO QUEEN'S MOSQUE AND TOMB AT SARANGPUR, AHMEDABAD, INDIA

Sanjay Prasad Gupta*¹ and Sachin Kumar Agnihotri²

¹National Research Laboratory for Conservation of Cultural Property (NRLC), Lucknow (U.P.), India

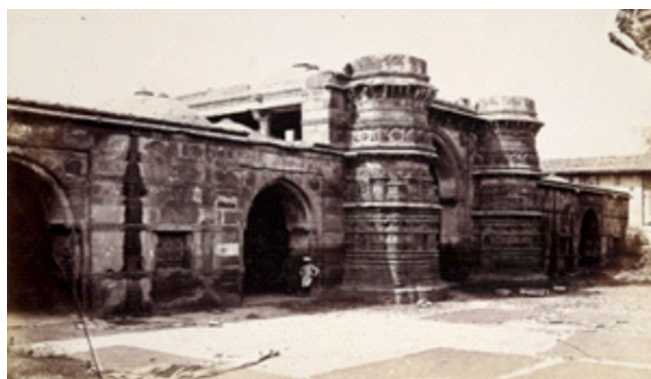
Fig.1: Front view of Queen's Mosque showing fungal growth on the surface.

side of the centre or now unfortunately extant up to the roof only, resemble closely those of Bibi-ki-Masjid of Rajpur. The front wall behind the minars is raised on the central portion to about 2.74 meters along a stretch of 12.80 meters (Fig. 1) but on the interior, there is only a kind of balcony to the gallery resting on pillars of normal height (Fig. 2). This is further connected with the gallery under the central dome. The front wall has four perforated windows while on the back wall there are six, with two at the side walls.
