Case Report

Epidural catheter catastrophe – Breakages during procedure and outcome in three cases

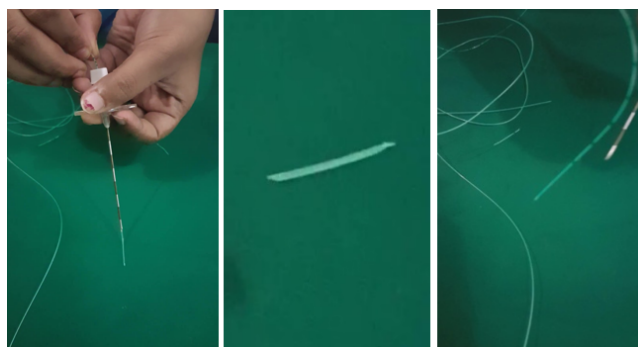
Fig. 1: Images showing broken tip of epidural catheter during attempted withdraw.

We tried to examine EPI CATH[®] SFT- Romsons in vitro, (Figure 1) when we introduced the catheter we observed that when it crosses the needle tip the catheter tends to break or felt resistance at a specific area and gets shear off. The sharp tip of the Tuohy needle and the relatively rigid catheter as compared to PORTEX[®] Epidural Catheter might be the reason.^{15,16}

Guidelines for insertion and removal of catheters should be followed to prevent shearing. Catheters should also be manufactured with materials that are high tensile strength, more resistant to breakages or shearing off. The presence of fragment should be documented and communicated to patients and surgeons, since neurological symptoms can develop months or years later. Therefore patient should be reviewed regularly and if symptoms develop, imaging studies and surgery are advocated.
